SYLWRAP Case Study

600mm Asbestos Cement Pipe Sleeve Repair

A buried 600mm asbestos cement pipe leaking from both ends of a sleeve in Mexico required a flexible repair capable of effective application in a trench

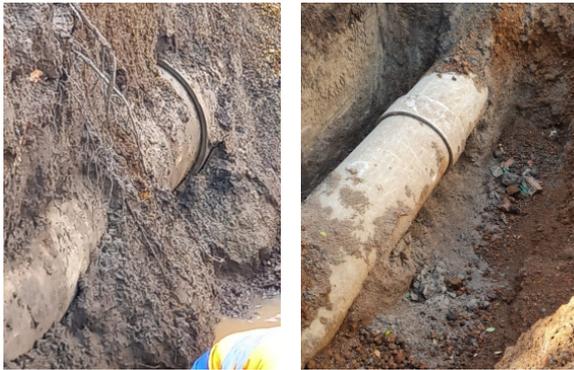
A trench was dug to attend to the buried pipeline

Water was leaking from both ends of a sleeve. Replacing the damaged section would have been difficult as the pipe passed under a building 10 metres away from the leak area.

To reach the pipe, a trench was dug affording room of 0.5 metres one side, 1.7 metres the other and minimal space between the line and the ground. Any repair had to be effective in tight constraints.

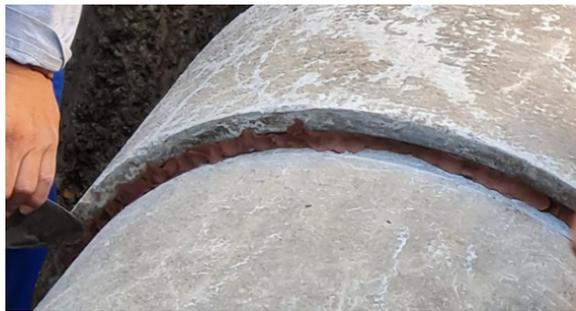
Superfast Copper sealed the gaps between the sleeve and the surface of the pipe

The gaps between the sleeve and the pipe surface were plugged at both ends by pushing **Superfast Copper Epoxy Putty** deep into the spaces.

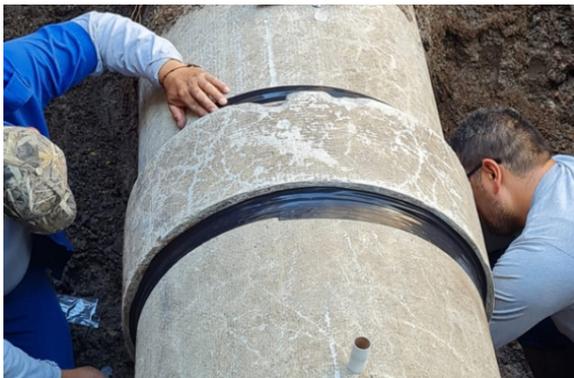
Wrap & Seal was used to reinforce Superfast Copper

Despite the space constraints, **Wrap & Seal Pipe Burst Tape** was wrapped around each joint for further reinforcement of the putty.

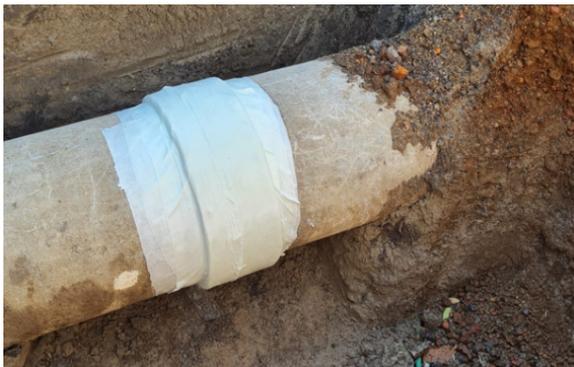
SylWrap HD encompassed the sleeve, completing the repair

The sleeve was encompassed with a **SylWrap HD Pipe Repair Bandage**, providing an rock hard protective shell before the pipe was re-buried.
