SYLWRAP Case Study

Leaking Coupling Repair in Pipe Pit

Two leaking coupling joints connecting a 2 metre section of 650mm ductile iron pipe to a mains water line through a disused pipe pit undergo repair

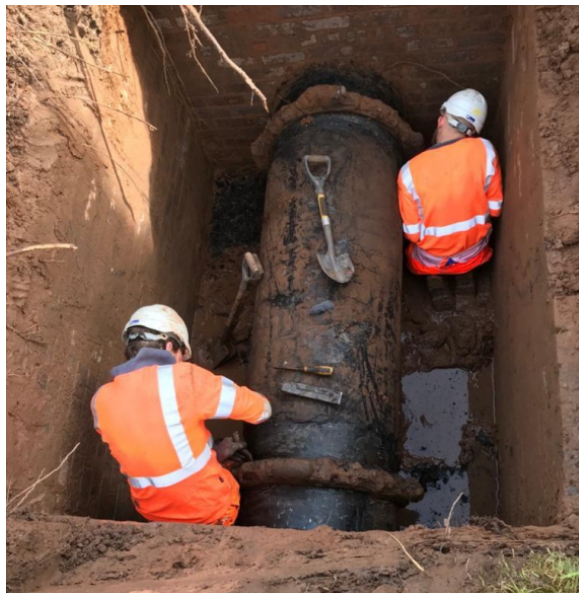
Location of the 2 metre section of pipe within pit

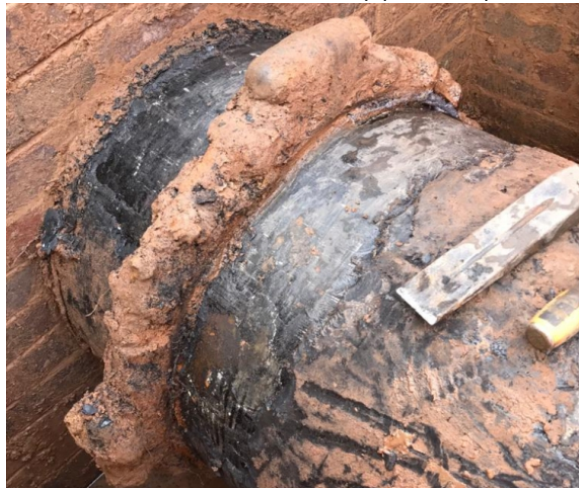
Each coupling was 80mm wide but rose 100mm off the pipe, creating an awkward ridge that needed to be sealed. With only 35mm clearance between the couplings and the floor of the pit, a repair method needed to be effective in tight spaces.

Raised couplings created a difficult ridge shape to seal

A polythene sheet was squeezed underneath to prevent mud and dirt being picked up during the application of **Wrap & Seal Pipe Burst Tape**.

Multiple Tapes were used and fused to each other, building up a repair over and around the couplings which sealed the leaks despite the difficult ridge.

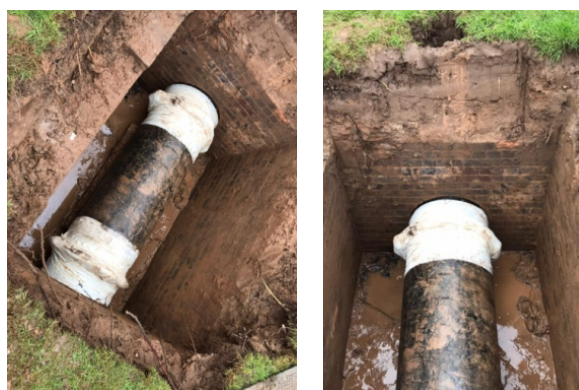
Completed repair prior to reburial of the pipe

SylWrap HD Pipe Repair Bandage was applied to encompass the couplings and the surrounding areas. 300mm wide SYL1266HD wraps provided enough coverage to mould around the couplings, fortifying both ends of the pipe before reburial.
