SYLWRAP Case Study

Libya 200mm 44 Bar Fuel Oil Line Repair

An underground oil line in Brega operating at temperatures up to 70°C and under 44 bar pressure undergoes repair after heavy corrosion led to a crack

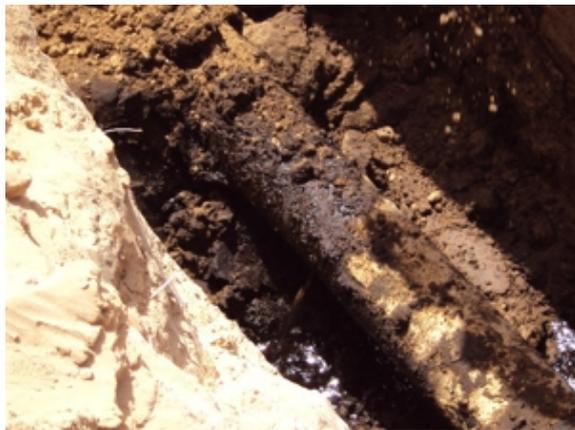
Pipe covered in dirt, rust and oil following excavation

Excavation of the line revealed that it was in terrible condition, badly pitted and covered in oil which had escaped from a small crack caused by corrosion.

Prior to the repair, the pipe was cleaned as best as it could be. Oil and dirt were removed to enable a good connection between the surface and **Wrap & Seal Pipe Burst Tape**.

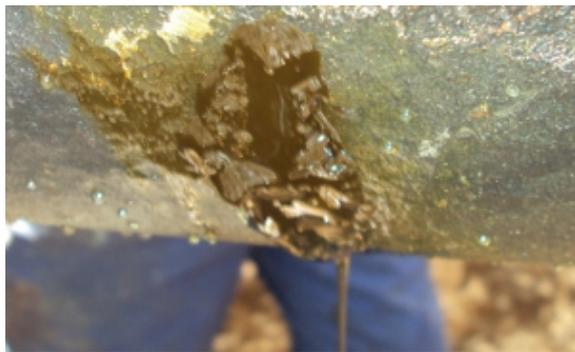
Oil was escaping from a crack caused by corrosion
