# SYLWRAP Case Study

## Seawater Cooling Line Snapped Nozzle Repair

Petrochemical plant in Saudi Arabia make an urgent repair & reinforcement of a 1500mm seawater cooling line after a snapped nozzle left a 50mm hole

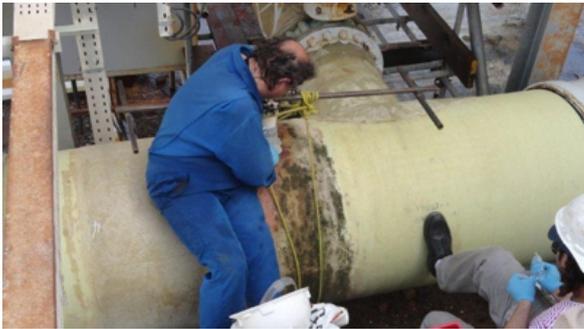
The pipe was the main supply line in the seawater cooling system, extracting from the Red Sea. When the nozzle snapped from a flange, it left a 50mm hole through which water was discharging 5 metres vertically at a pressure of 3 bar.

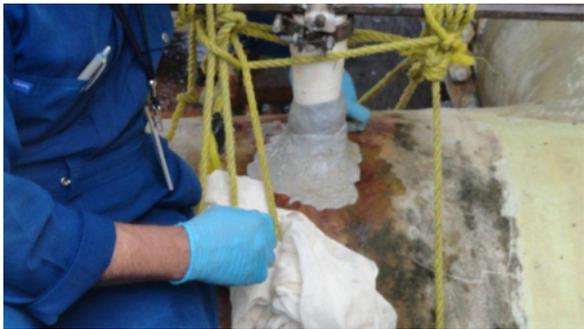
The pipe surface had been damaged and weakened by the 5 metre high water discharge through the hole

Losing so much water impacted on the efficiency of the system. When the water returned to ground, it saturated the pipe surface, causing damage, discolouration and mould, weakening the line.

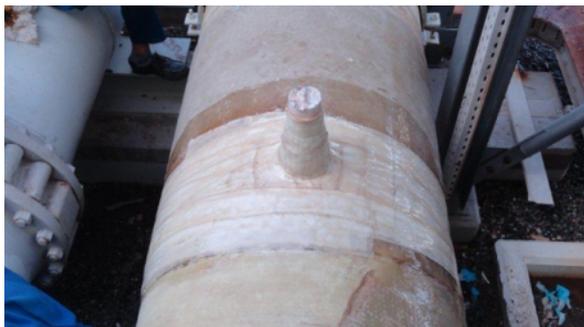
When the line was put back into operation, water and air was noticed bubbling at the pipe surface below the hole. To strengthen this section from future breaches, 4 layers of SylWrap were applied around the 1500mm diameter.

Further reinforcement was given to the plug and AB Original by seven layers of SylWrap HD

Repair was completed by encompassing weakened section of pipe with a protective sleeve of SylWrap HD, strengthening it against future breaches

Seven layers of **SylWrap HD Pipe Repair Bandage** reinforced the plug and surrounding AB.
