# SUPERFAST STEEL STICK

## 900mm Steel Water Main Flange Leak Repair

Multiple cracks in a 900mm water main flange flooding an underground chamber in Malaysia are sealed in a repair previously thought impossible

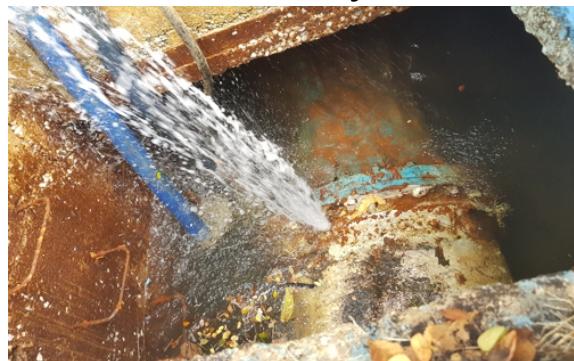
Pressurised water was escaping multiple cracks in the main, flooding the underground chamber

Corrosion had left cracks around a stub flange in the 900mm steel water main in an underground chamber. A repair clamp could not be fitted and there was no space around the main to apply tapes or bandages.

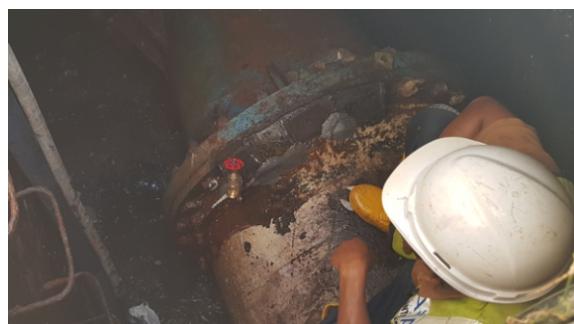
Pressure was turned back on and the repair inspected again the following day. Small cracks which remained were sealed with more putty. This left one final leak; a jet of water spraying out between the flange and pipe.

A valve fitting was fixed in place with Superfast Steel, channelling the final leak path through the valve

A tap was fitted to the valve, containing the final leak and completing the 'impossible' repair

The engineering team leader hit upon the idea of using Superfast Steel to bond a valve over the remaining leak. Water was now channelled directly through the fitting, which was tapped off to seal it.
