# Industrial Metal Case Study

### Delivery Truck Cracked Engine Timing Cover Repair

Industrial Metal repairs a crack in a 466 International engine cover, saving a Puerto Rico dairy \$1000 in parts and a week downtime for a delivery truck

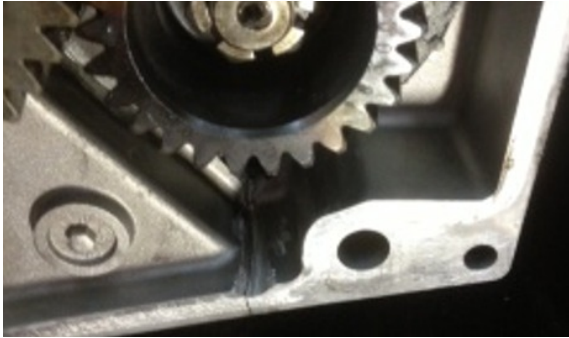
The hairline crack can just about be seen in the centre of the metal casing

Oil was noticed leaking from the timing cover of a dairy delivery truck's 466 International engine. Once opened, a hairline crack was found inside the casing.

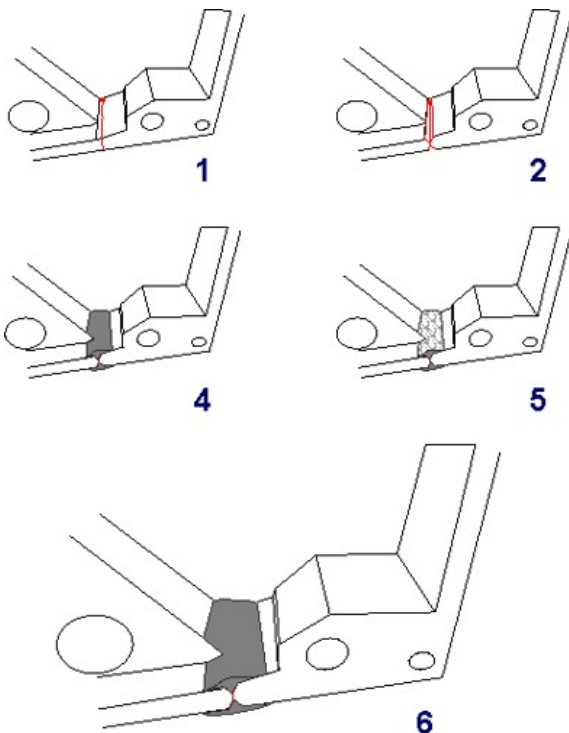
Repair instructions, showing V-shaped grooves cut into the top and bottom of the crack and a 20mm paste overlap to ensure full adhesion

The ends of the hairline crack were drilled to relieve stress concentration and prevent it spreading.

A coarse 3-square file was used to widen the top and bottom of the crack, creating two V-shaped grooves in the casing.

The paste was forced into both ends of the crack with a spatula, filling the widened V-shapes. To ensure full adhesion, Industrial Metal was overlapped by 20mm either side of both grooves.

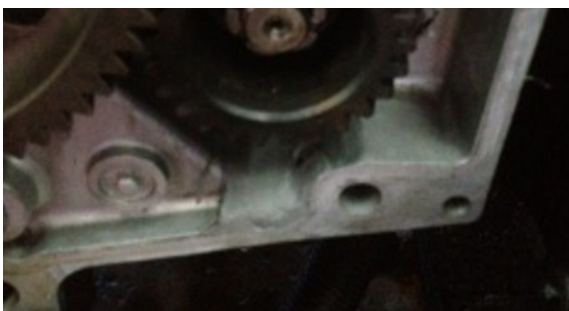
Completed repair with the crack seamlessly filled

Industrial Metal has a full cure time of 24 hours. Once set, it formed a metallic material which seamlessly filled both grooves to repair the crack.
