# Industrial Metal Case Study

## Cracked Engine Timing Cover Repair

Industrial Metal repairs a crack in a 466 International engine cover, saving a Puerto Rico dairy \$1000 in parts and a week downtime for a delivery truck

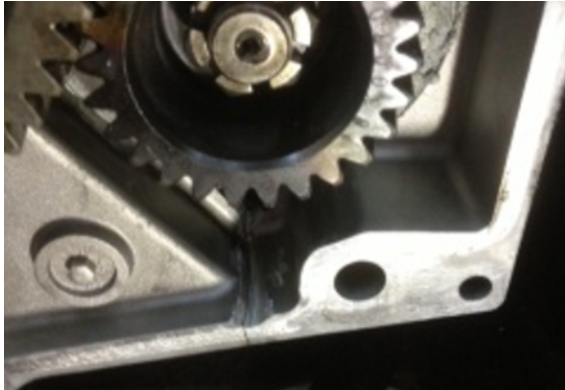
The hairline crack in centre of the metal casing

Oil was noticed leaking from the timing cover of the delivery vehicle's 466 International engine. Once opened, a hairline crack was found in the casing.

The ends of the hairline crack were drilled to relieve stress concentration and prevent the crack from spreading further.

A coarse 3-square file was used to widen the top and bottom of the crack, creating two V-shaped grooves in the casing. This increased the surface area with which **Industrial Metal Epoxy Paste** could bond when rebuilding the metalwork.

The paste was forced into both ends of the crack with a spatula, filling the widened V-shapes. To ensure full adhesion, the paste was overlapped by 20mm either side of both grooves.

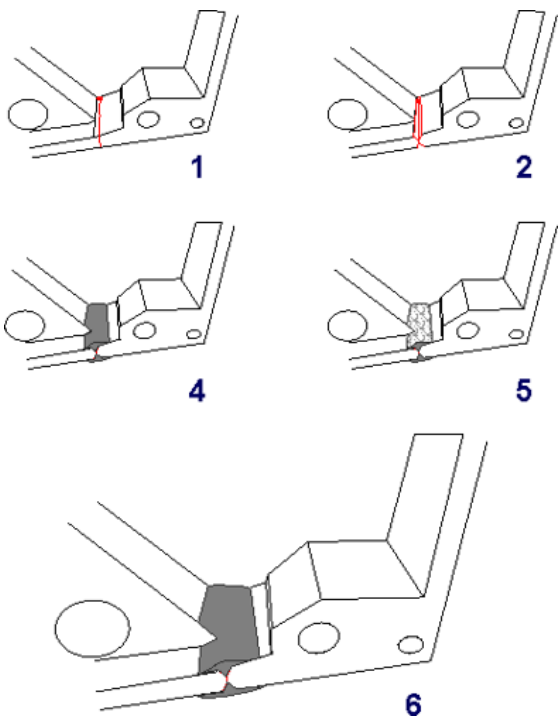
Repair instructions, showing V-shaped grooves cut in top and bottom of crack and 20mm paste overlap

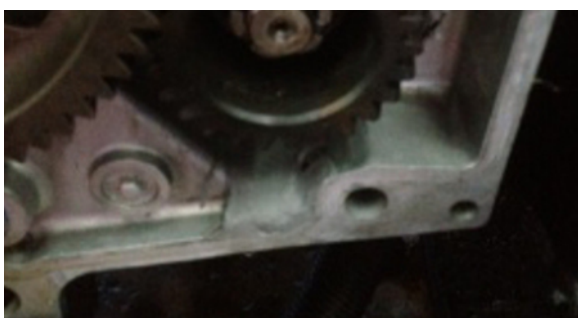
Completed repair with crack seamlessly filled in

Industrial Metal has a full cure time of 24 hours. Once set, it had formed a solid metal material seamlessly filling the grooves to repair the crack.

A day after the application had been completed and the delivery truck was back on the road with the timing cover no longer leaking.
