SUPERFAST **STEEL STICK** Case Study

400mm GRP Pipeline Surface Damage Repair

Areas of external surface damage on a 400mm GRP line at an oil refinery are repaired to restore the integrity of the pipe and help prevent future leaks

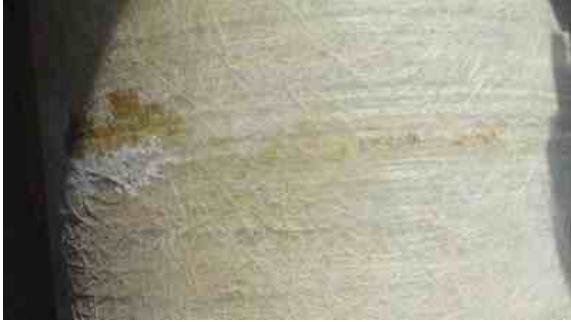
The external surface of the GRP pipe was suffering from heavy scoring which had the potential to lead to future breaches of the line

Construction work led to the excavation of an underground section of 400mm GRP pipe. The surface of the line was found to be damaged, with two areas suffering from heavy scoring.

Whilst the pipe remained accessible, the refinery decided to strengthen the line and restore its integrity by repairing the weakened areas.
