SYLWRAP Case Study

Seawater Cooling System FRP Return Pipe Repair

A leaking 3 metre diameter FRP return pipe in a seawater cooling system is repaired in just two days, keeping downtime at an oil refinery to a minimum

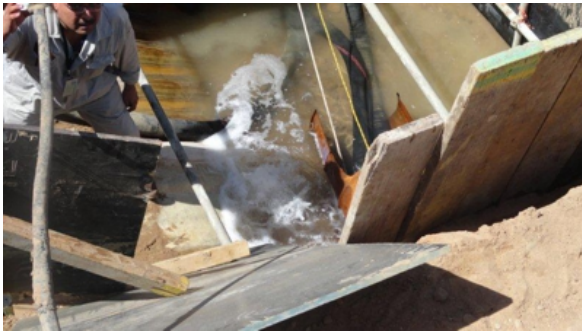
The line was isolated, excavated and re-pressurised. So much water escaped that the hole dug to access the pipe became instantly flooded

When the ground above a return pipe was noticed to be wet, the line was isolated and excavated. Once accessed, the line was re-pressurised. So much water escaped from several areas that the hole dug to reach the pipe was instantly flooded.

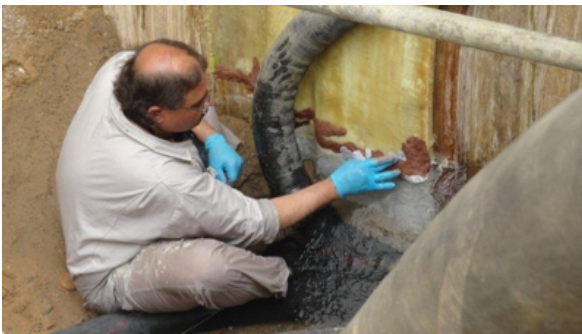
Superfast Copper sealed smaller holes in the line

Needing a rapid repair, two epoxy putties were used to seal the pipe. **Superfast Copper Epoxy Putty Stick** was pushed into the smaller holes.

The 5 minute work time of Superfast Copper was accelerated by the climate. A putty with a longer work life was required for the bigger holes, so that it could be mixed and applied over a larger area.

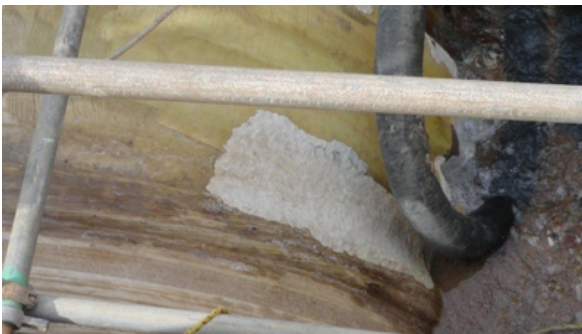
Sylmasta AB Original was used for larger leak areas because of its longer work time

Sylmasta AB Original Epoxy Putty was used because of its two hour work time and availability in bulk quantities beyond a 114g stick.

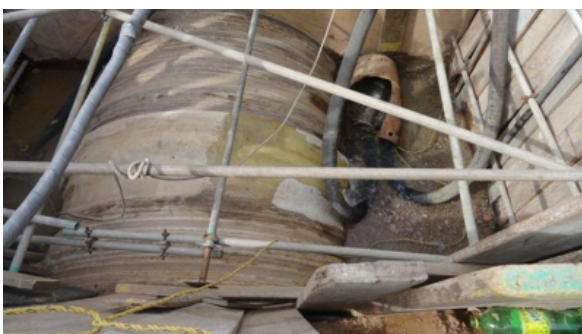
The line successfully sealed prior to being re-buried

Both putties achieved full properties after 24 hours. The line was then turned back on. No water was escaping, meaning the repair was a success and the pipe could be re-buried.
