# SYLWRAP Case Study

## Encapsulation of Capped Pipe Stub at Landfill

A capped pipe in a decommissioned drainage system at a landfill site is encapsulated to protect it from corrosion and a potential leak of toxic leachate

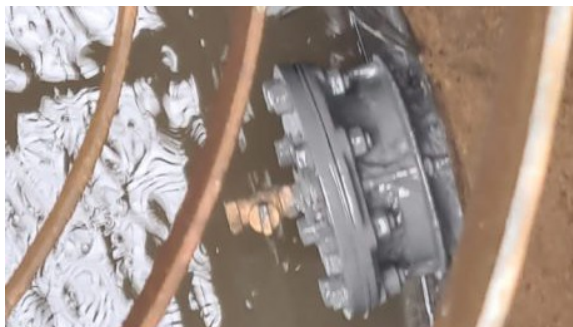
The pipe stub was difficult to access at the bottom of a chamber surrounded by metalwork

The stub protruded 300mm from a concrete wall towards the bottom of a chamber. There was little room to move and access was further restricted by various metal structures above the stub.
