# SYLWRAP Case Study

## Pipe Flange Sealed Against Tree Root Ingress

After a tree penetrated a flange on an underground 1800mm steel pipe, a wastewater treatment plant seal the line to prevent future root ingress

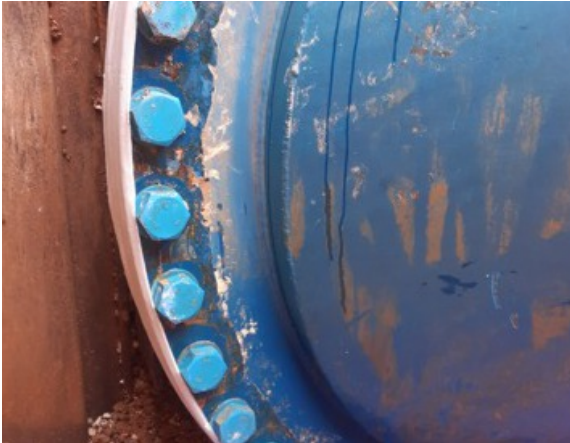
*The flange connected a steel pipe to a chlorine tank*

The pipe brought wastewater to a chlorine contact tank. After a reduction in performance was noticed, the pipe was excavated to identify the problem.

A tree root had penetrated between two flange plates. The pipe was seeping and partly blocked, causing possible recontamination of water which had undergone most of the treatment process.

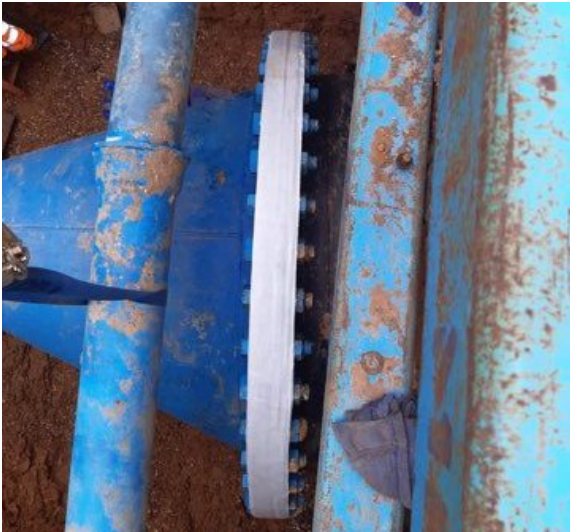
*Wrap & Seal was applied all around the flange to seal the leak. It was then overwrapped with SylWrap Pipe Repair Bandage*

**Wrap & Seal Pipe Burst Tape** was wrapped over the point where the flange plates connected. Several Tapes were applied over each other, bonding together to build pressure resistance.

Once no more water was seeping from the flange, **SylWrap HD Pipe Repair Bandage** was applied over the top. A SYL412HD Bandage was used as its 100mm width fitted perfectly over the flange.

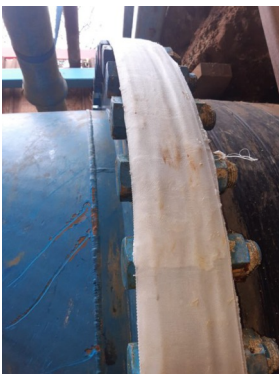
*A SYL412HD Bandage was the perfect 100mm width to wrap around the flange, curing to form a rock-hard shell which tree roots would not be able to penetrate in future*

SylWrap Bandage cured to form a rock-hard shell around the flange. This reinforced the initial leak repair and ensured the line could not be penetrated through the weak spot between flange plates again.
