# SYLWRAP Case Study

## Pipe Flange Sealed Against Tree Ingress

After a tree penetrated a flange on an underground 1800mm steel pipe, a wastewater treatment plant seal the line to prevent future root ingress

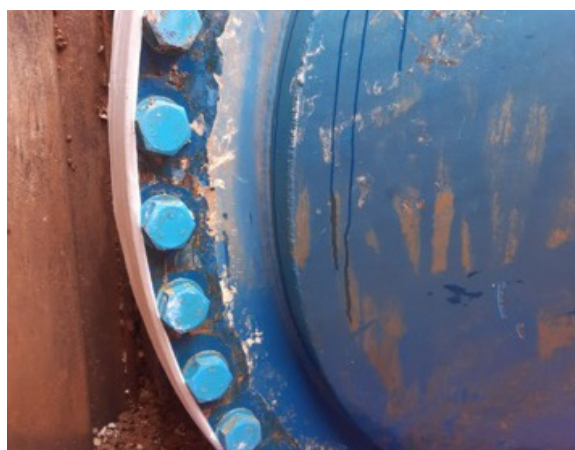
*The flange connected a steel pipe to a chlorine tank*

A tree root had penetrated between two flange plates. The pipe was seeping and partly blocked, causing possible recontamination of water which had undergone most of the treatment process.
