Epoxy Putty Case Study

Cracked Wall Between River and Trout Farm Repair

The Environment Agency repair a crack in an underwater wall between a river and a trout farm which was causing issues with the monitoring of water levels

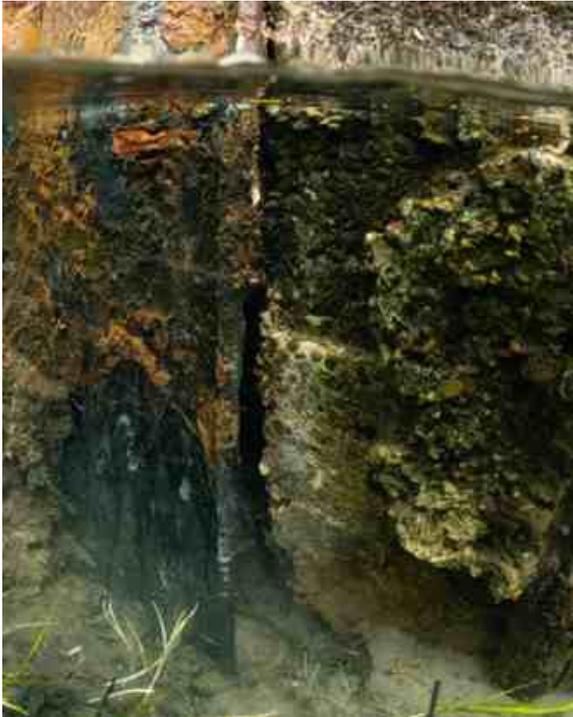
The crack ran for 700mm, starting above the waterline and progressing down to the riverbed

Anomalies with data from one farm alerted the EA to an issue. An inspection revealed a 700mm long crack in a wall next to a sluice.

The crack needed sealing to prevent water loss from river to farm, and ensure accurate recording of how much water was being drawn.

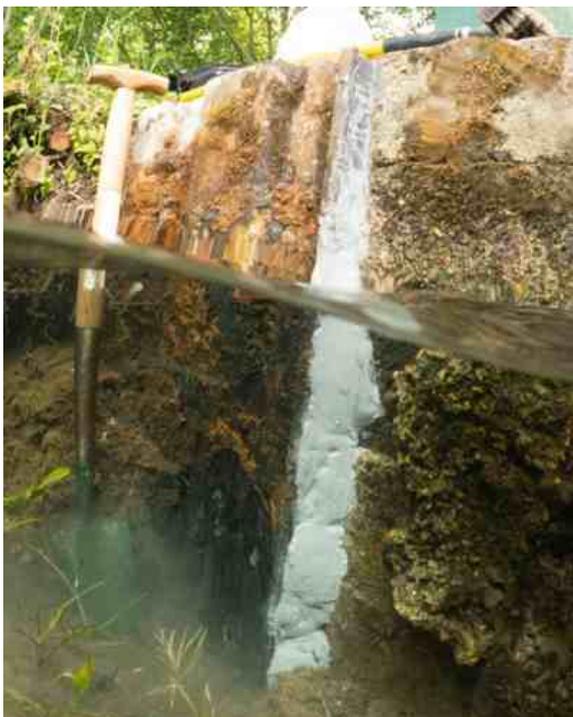
Monitoring of water levels after the repair showed a small leak remained. This was identified as being at the crack's widest point near the riverbed. It was sealed with further AB Original on a second visit.

AB Original was pushed into the crack, sealing along its entire length above and below the waterline

The putty was mixed in dry conditions. Whilst soft, it was pushed into the crack. The repair started above the waterline, working down to the riverbed.

High-strength adhesion was achieved between AB Original and the wall. Once cured, the putty formed a rock-hard material to permanently fill the crack.
