SYLWRAP Case Study

Chemical Plant 350mm Effluent Pipe Repair

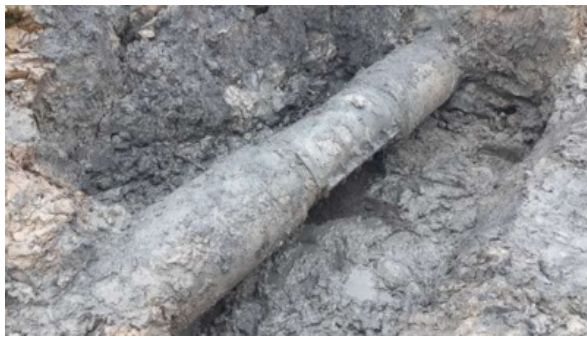
The leaking section ran beneath salt marshes, leaving an eight hour window whilst the tide was out to access, excavate and clean the pipe, and seal the leak

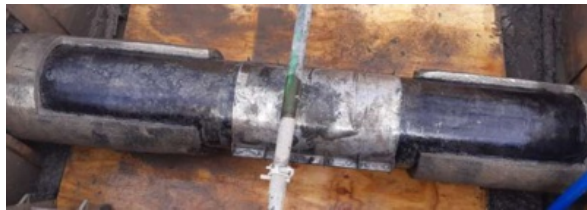
The pipe carried effluent from the chemical plant underneath salt marshes and out to sea. It was leaking from both ends of a clamp fitted as part of a previous failed repair.

Effluent was escaping from both ends of a failed pipe repair clamp, seen in the centre of the pipe.

The steel pipe beneath the clamp had deteriorated to the point there was a risk that removal of the clamp could have led to a collapse of the line.

It was decided to leave the clamp in place and encapsulate it with **Sylmasta AB Original Epoxy Putty**. AB was applied around the clamp, curing to form a super-strength shield able to withstand the harsh environment of the salt marshes.

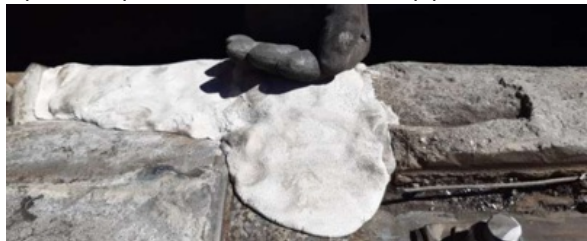
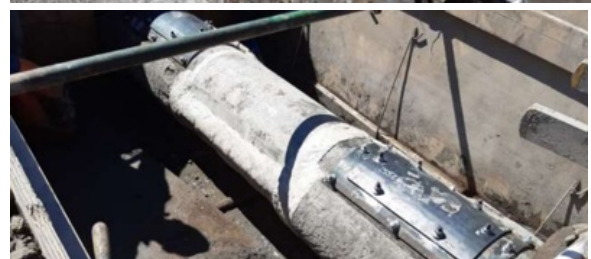
AB Original encapsulated the clamp, sealing all areas which the pipe was leaking from

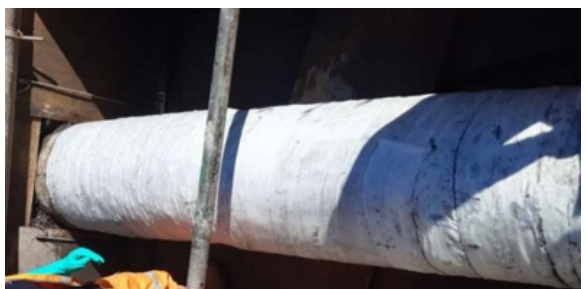
SylWrap HD was wrapped across the entire length of the pipe, completing the repair

A concrete coating was applied over the excavated section, followed by several layers of **SylWrap HD Pipe Repair Bandage**. SylWrap HD created an impact-resistant protective sleeve, uniting and strengthening the weak and solid areas of repair.
