# SYLWRAP Case Study

## Corroded Steel Gas Pipe Refurbishment

An industrial plant refurbish and repair a three metre section of corroded steel pipe hung from a ceiling and carrying natural gas as part of a CHP system

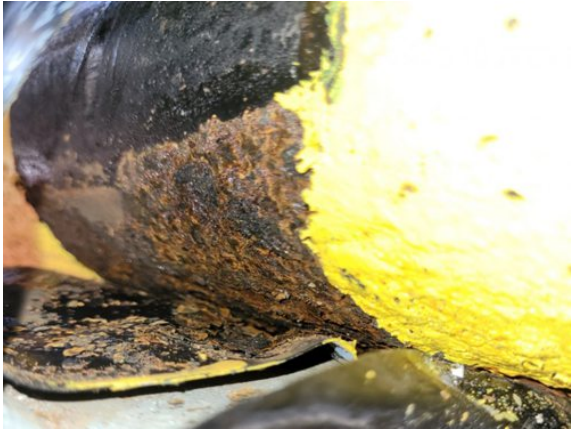
*The pipe was heavily corroded where water had been trapped between a protective PVC tape and the line*

When installed, the pipe had been wrapped with a protective PVC tape. Incorrect application had left a three metre section where water could become trapped between the tape and the line.

This had caused heavy corrosion, particularly weakening the pipe area resting on the U-support.

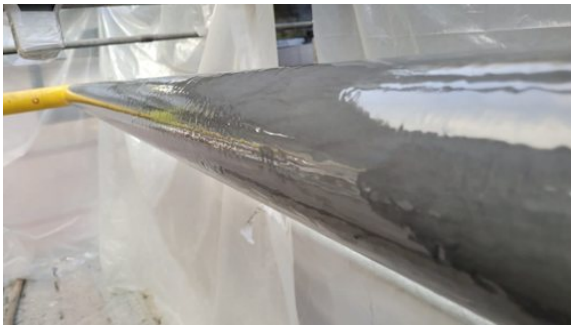
*Rust, grime and paint were ground off the pipe and the three metre section coated in Liquid Metal*

The U-support was cut away to better access the line and the tape removed. The pipe was cleaned before **Liquid Metal Epoxy Coating** was applied.

Liquid Metal formed a smooth, hard-wearing, outer metallic surface which acted as shield for the line against external corrosion and chemical attack.

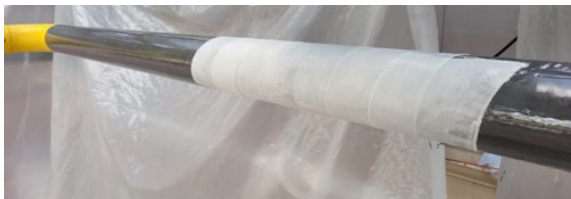
*SylWrap HD increased the thickness of the weakened area where the pipe had contact with the U-support*

A **SylWrap HD Pipe Repair Bandage** was wrapped around the section which had contact with the U-support, increasing the thickness of the weakened area and providing additional protection.

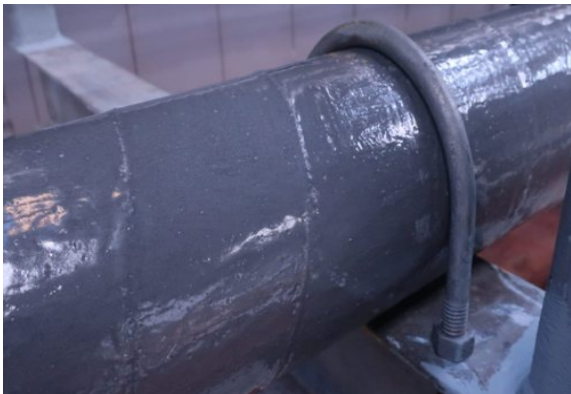
*A second Liquid Metal coating was applied over SylWrap HD and the pipe fixed to the U-support*

Another coating of Liquid Metal was added over the SylWrap Bandage to improve the appearance of the pipe. The U-support was welded back in place and the pipe fixed to it via a clamp to reduce vibrations.
