SYLWRAP Case Study

Corroded Shared Water Supply Pipe Repair

A 48 metre long shared water supply pipe attached to the back wall of eight cottages required repair after heavy corrosion caused leaks to appear

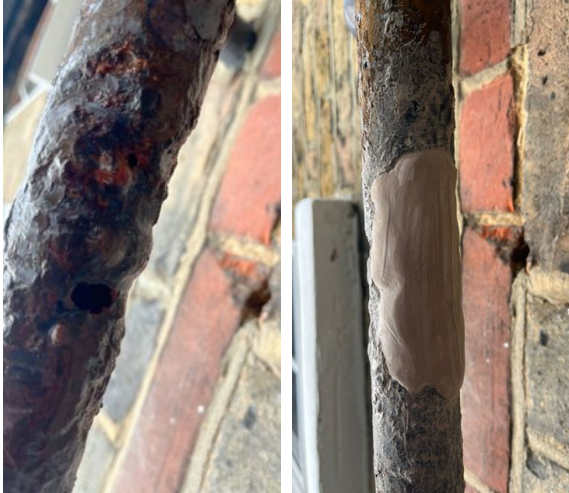
Low-quality lagging had trapped moisture against the steel pipe, causing corrosion along the whole 48 metre line which led to holes in multiple places.

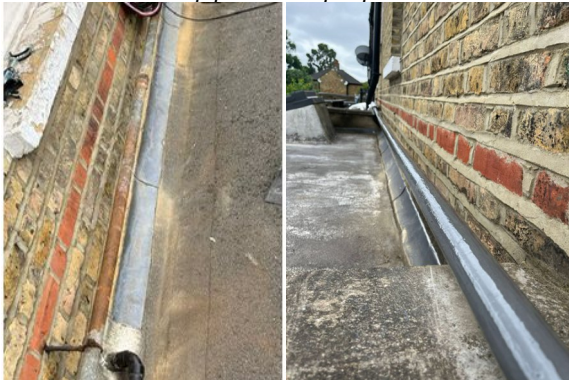
Superfast Aqua PW sealed holes where corrosion had breached the pipe in multiple places

A Sylmasta approved contractor worked on two cottages initially. Holes were sealed with **Superfast Aqua PW Epoxy Putty**, used for its wet surface adhesion amid concerns the pipe may be weeping.

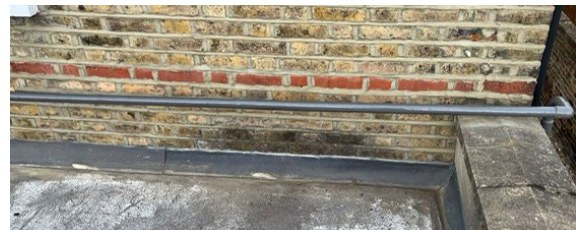
The pipe was painted in Liquid Metal to reinforce and strengthen the brittle, corroded metalwork

Liquid Metal Epoxy Coating was painted onto the two sections to form a new metallic, hard-wearing outer surface. This strengthened the pipe and acted as a shield against external corrosion.

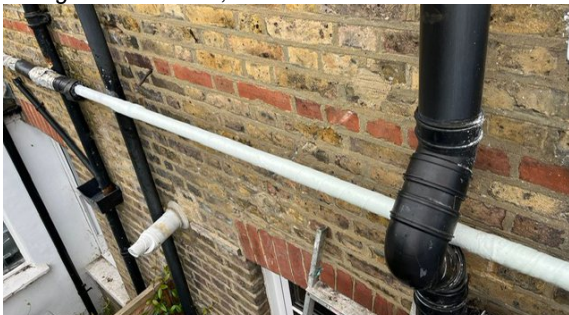
SylWrap HD was applied over the Liquid Metal coating, forming an impact resistant shell

Four layers of **SylWrap HD Pipe Repair Bandage** were then wrapped around the two sections, encompassing them with an impact resistant shell.
