# SYLWRAP Case Study

## Corroded Shared Water Supply Pipe Repair

A 48 metre long shared water supply pipe attached to the back wall of eight cottages required repair after heavy corrosion caused leaks to appear

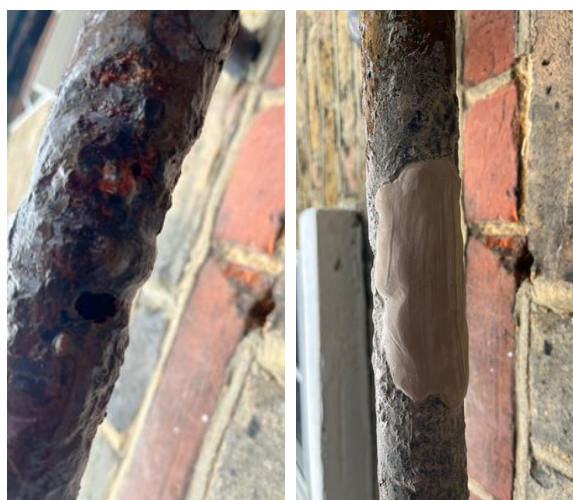
*Superfast Aqua PW sealed holes in where corrosion had breached the line in several places*

Low-quality lagging had trapped moisture against the steel pipe, causing corrosion along the whole 48 metre line and holes in several places.

A Sylmasta approved contractor worked on two cottages initially. Holes were sealed with **Superfast Aqua PW Epoxy Putty**, used for its wet surface adhesion amid concerns the pipe may be weeping.

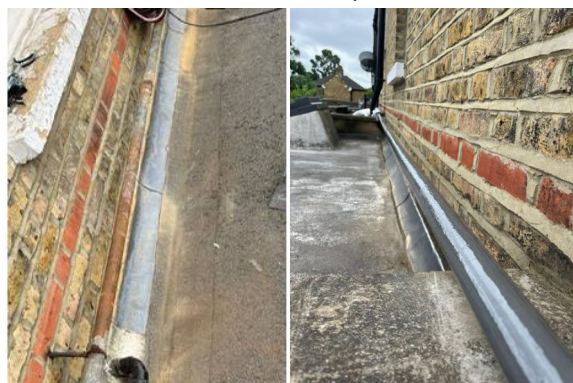
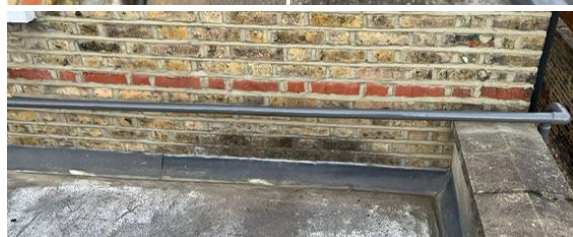
*The heavily corroded pipe was painted in Liquid Metal to reinforce and protect the brittle metalwork*

**Liquid Metal Epoxy Coating** was painted onto the two sections to form a new metallic, hard-wearing outer surface. This strengthened the pipe and acted as a shield against external corrosion.

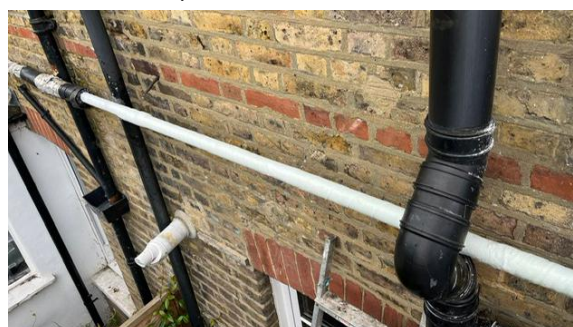
*SylWrap HD was added over the Liquid Metal coating to encompass the pipe with an impact-resistant shell*

Four layers of **SylWrap HD Pipe Repair Bandage** were then wrapped around the two sections, encompassing them with an impact resistant shell.
