SYLWRAP Case Study

Ductile Pipe System Corrosion Protection

Corrosion protection measures are made to a 600mm ductile pipe system showing early signs of surface damage in an underground pumping station

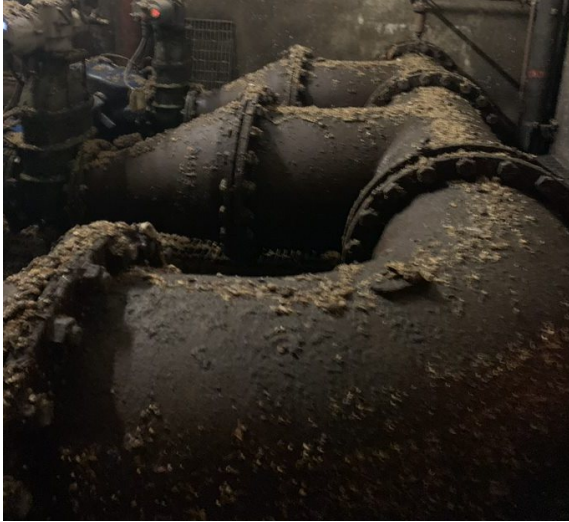
The pipe system was covered in contaminants and showing early signs of external surface damage

Conditions inside the chamber were ripe for corrosion. Rainwater, sand and other contaminants could settle on the pipe, causing early signs of surface damage.

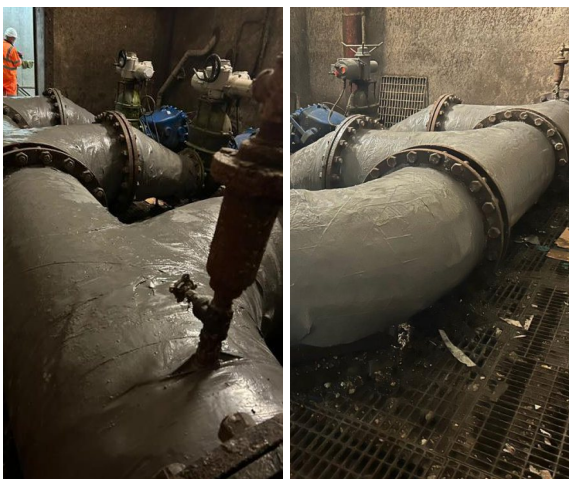
Liquid Metal and SylWrap HD combined to form a robust outer shield protecting against corrosion

Liquid Metal and SylWrap HD combined to leave the pipework system with a robust outer shield protecting it from conditions in the chamber.
