Epoxy Putty Case Study

Coal Mine Repair Cracked C6 Concrete

A coal mine in Australia make superficial repairs to C6 concrete footings and walls after subsidence caused cracks and unsightly surface damage to appear

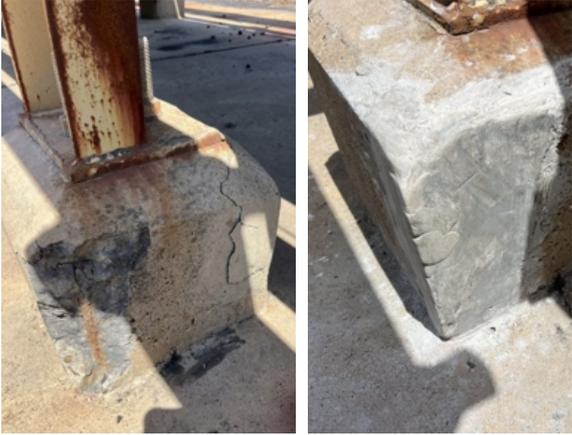
Areas of C6 concrete which had crumbled away from footings because of ground movement at the mine were rebuilt using AB Original Epoxy Putty

But once coal production began, the ground started moving more than expected. Within five years, cracks were appearing and chunks of C6 crumbling away.

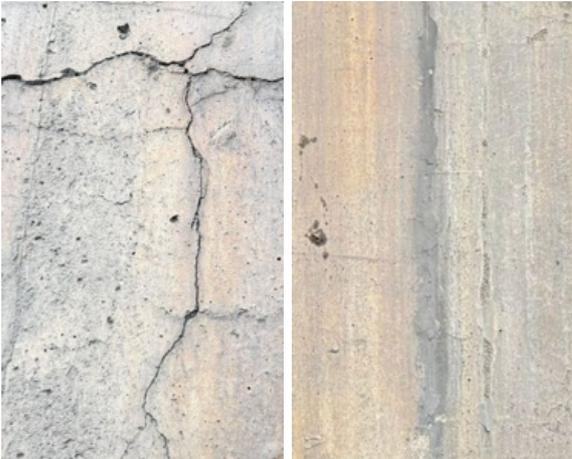
AB Original sealed and filled all visible cracks in walls and other concrete structures

Whilst soft, AB Original was forced into gaps or cracks until they were filled. Where C6 had broken away, the putty was shaped, moulded and applied to replace and rebuild missing concrete.

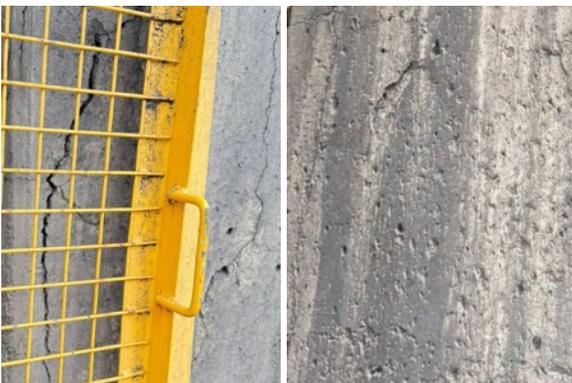
Smoothing off AB Original with a little water disguised the repair so it was impossible to tell the difference between the original concrete and epoxy putty

Once applied, AB Original was smoothed off with a little water to give it a concrete-like appearance. The final repair was so seamless, it was impossible to tell the difference between original concrete and putty.
