SYLWRAP Case Study

ASME PCC-2 402-III Qualification Testing

Superfast Aqua PW Epoxy Putty and SylWrap HD Pipe Repair Bandage make a leak repair tested as passing ASME PCC-2 401-III qualification

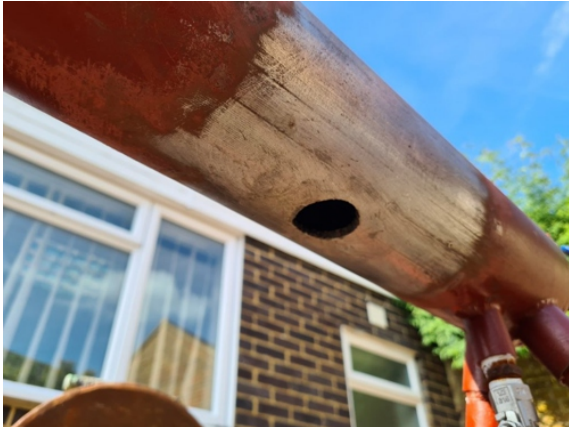
A 25mm hole was cut into the 110mm diameter carbon steel pipe for the qualification test

A 25mm hole was cut into a steel pipe. To qualify for PCC-2 402-III, the leak needed to be sealed and the repair withstand three pressure tests up to 30 bar.

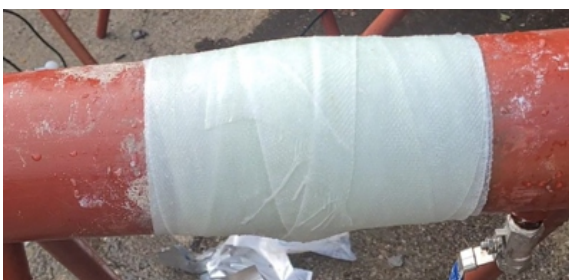
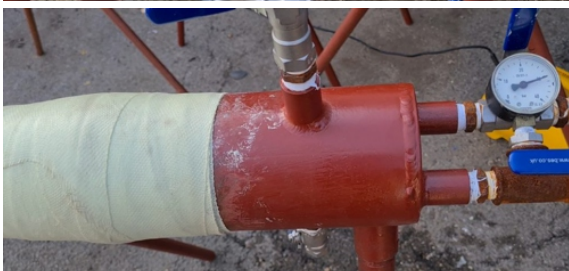
SylWrap HD reinforced the repair, after which it withstood three separate pressure tests up to 30 bar

With no leak or defect detected during any of the three tests, Superfast Epoxy Putty and SylWrap HD are qualified to meet PCC-2 402-III standard.

Whilst the putty was gelled but not fully cured, **SylWrap HD Pipe Repair Bandage** was applied over the top.

SylWrap helped force the putty deeper into the hole for a more effective seal, whilst also creating a thick, rock hard outer sleeve around the pipe.
