# SYLWRAP Case Study

## Contaminated Wastewater Pipe Live Leak Repair

A rapid live leak repair of a 450mm contaminated water pipe at a wastewater treatment works helps prevent a damaging environmental incident developing

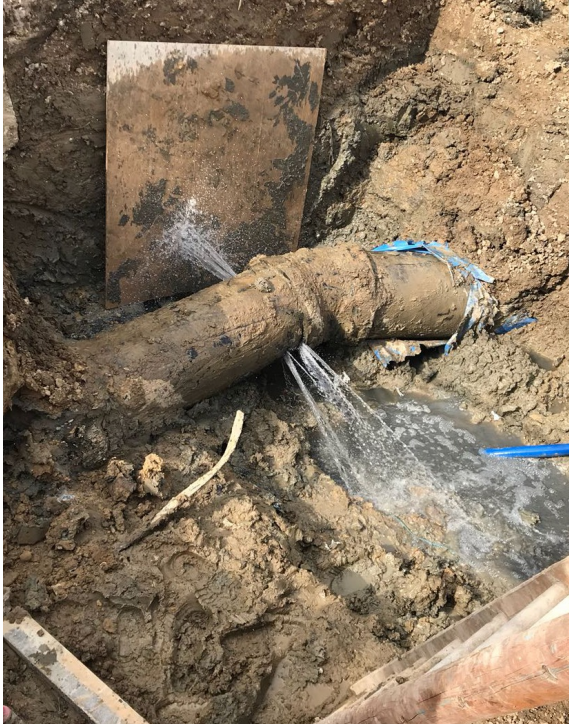
Significant amounts of contaminated water were left spraying out of the pipe after it was cut into

Infrastructure upgrades were taking place when contractors cut into a pipe they believed had been decommissioned and was due for removal.

In fact, it was one of the most important pipes at the site - still highly pressurised and linked to all waste treatment ponds. As soon as it was cut, a powerful jet of contaminated water began spraying out.

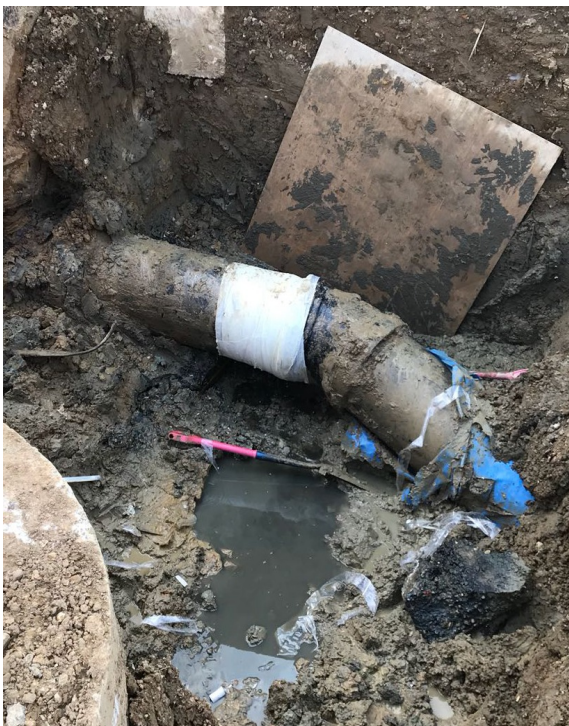
Wrap & Seal sealed the leak before overwrapping with SylWrap HD Bandage for a permanent repair

Multiple **Wrap & Seal Pipe Burst Tape** were wrapped around the pipe, fusing to form a solid rubber band containing the contaminated water.

The repair was then overwrapped with **SylWrap HD Pipe Repair Bandage** to provide it with a rock-hard, impact resistant layer of protection.
