SYLWRAP Case Study

Air Conditioning Water Return Pipe Repair

A London hospital required a rapid leak repair after a burst 300mm pipe forced a shutdown of the air conditioning on a day when temperatures reached 27°C

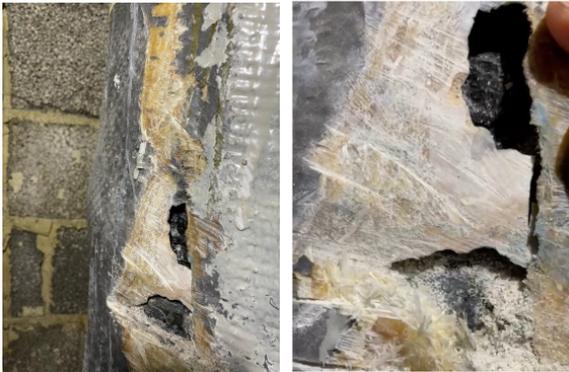
Water was leaking from two deep cavities in the pipe

The burst was through a previous repair attempt to a 300mm water return pipe. Two deep cavities were discovered on Sunday night and necessitated the shutdown of the air conditioning system as water escaping at 12 bar would have caused flooding.

Coarse fibreglass strands from the previous repair were cut away to better access the two cavities in the pipe and improve the chances of sealing.

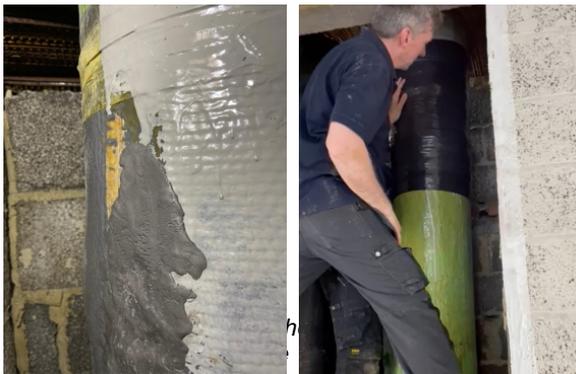
Superfast Steel and Wrap & Seal used to seal the leak

Superfast Steel Epoxy Putty was used to fill in the holes. The entire leak area was then wrapped with **Wrap & Seal Pipe Burst Tape** for added sealing security to eliminate any seepage around the putty.

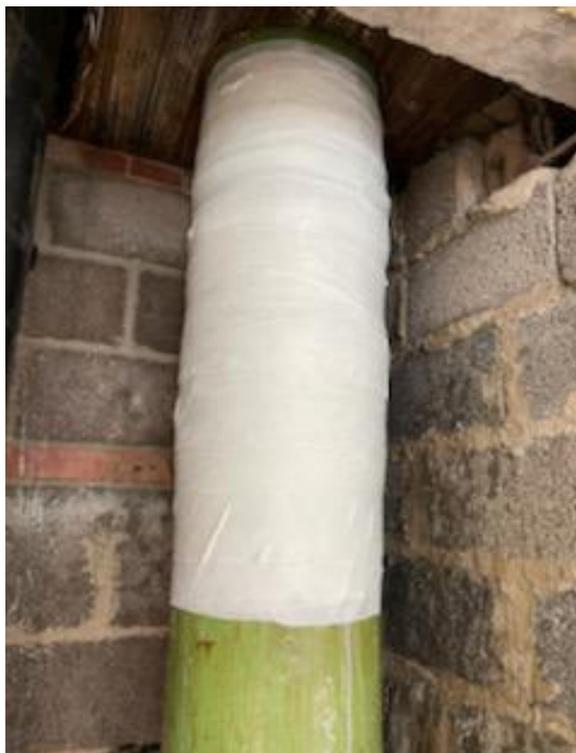
Two SylWrap HD Bandages completed the repair

The application was completed with two SYL866HD **SylWrap Pipe Repair Bandages** to provide a protective sleeve, further reinforcing the repair.
