# SYLWRAP Case Study

## Camper Van Boiler Copper Pipe Repair

A cracked copper pipe in a camper van boiler system leaking water whenever the heating or hot water was turned on undergoes repair despite limited access space

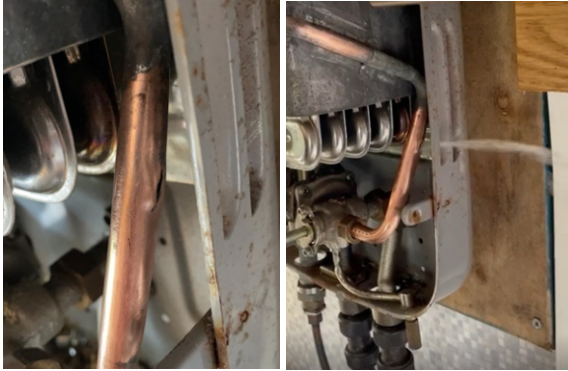
*The crack in the copper pipe was difficult to access. Whenever the boiler system was turned off, a jet of pressurised water sprayed from the hole*

Whenever the boiler system was switched on to provide heating or hot water for the camper van, a pressurised jet of water sprayed out from the crack.

The hole was located in a section of pipe underneath the boiler cover and facing towards the casing. This meant space to access the leak was very restricted.

It was therefore impossible to fit a pipe repair clamp over the leak, or for a self-amalgamating waterproof repair tape to be stretched by the required amount to successfully fuse into a solid rubber band.

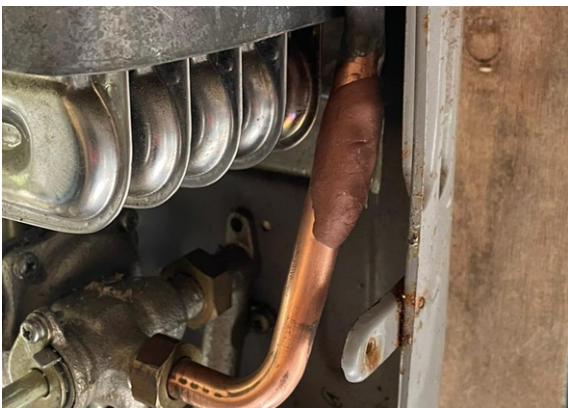
*Superfast Copper was kneaded by hand and used to cover the hole and surrounding areas of the pipe*

As the boiler could be turned off, **Superfast Copper Epoxy Putty** was used to seal the hole. The pipe was cleaned and dried before application to aid the adhesion of Superfast Copper to the metalwork.

The putty was kneaded by hand and applied to cover both the hole and surrounding area. It hardened within 10 minutes to fill the crack with a waterproof material.

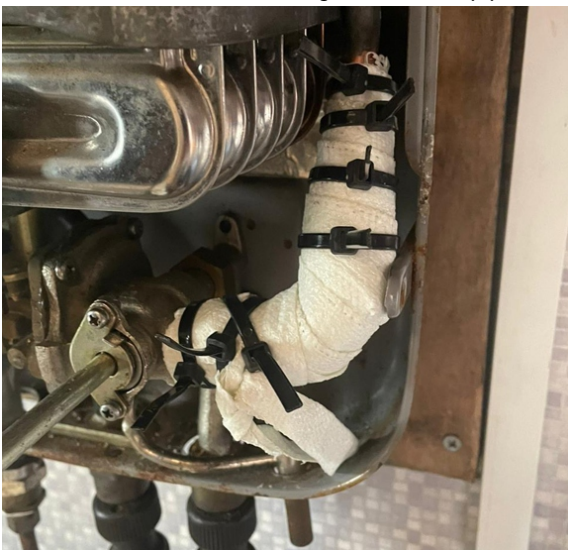
*The space constraints meant SylWrap HD was cable tied in place whilst it cured, reinforcing the repair with a rock hard, protective outer shell*

A **SylWrap HD Pipe Repair Bandage** was then applied around the entire pipe for reinforcement.

Wrapping in the normal manner was not possible due to the space constraints, so the bandage was cable tied to the pipe whilst it cured.

Once the repair was completed, the boiler was turned back on. No water was escaping the pipe, denoting a successful application.
