SYLWRAP Case Study

Camper Van Boiler Copper Pipe Repair

A cracked copper pipe in a camper van boiler system leaking water whenever the heating or hot water was turned on undergoes repair despite limited access space

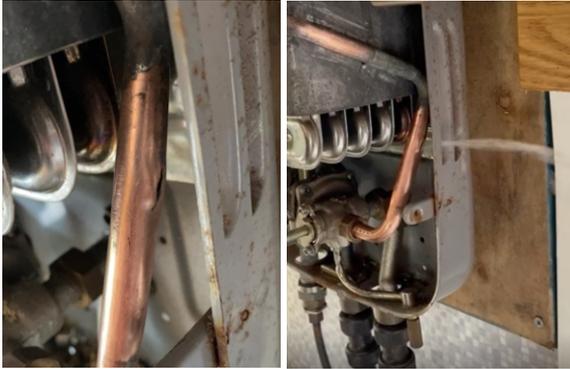
The crack in the copper pipe was difficult to access. Whenever the boiler system was turned off, a jet of pressurised water sprayed from the hole

Whenever the boiler system was switched on to provide a heat or hot water for the camper van, a pressurised jet of water sprayed out the crack.

The hole was located in a section of pipe underneath the boiler cover and facing towards the casing. This meant space to access the leak was very restricted.

It was therefore impossible to fit a pipe repair clamp over the leak, or for a self-amalgamating waterproof repair tape to be stretched by the required amount to successfully fuse into a solid rubber band.

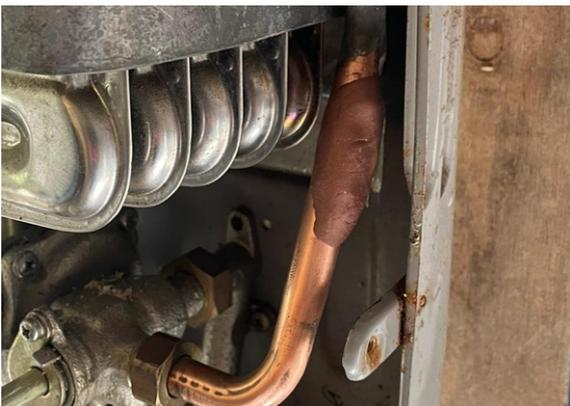
Superfast Copper was kneaded by hand and used to cover the hole and surrounding areas of the pipe

As the boiler could be turned off, **Superfast Copper Epoxy Putty** was used to seal the hole. The pipe was cleaned and dried before application to aid the adhesion of Superfast Copper to the metalwork.

The putty was kneaded by hand and applied to cover both the hole and surrounding area. It hardened within 10 minutes to fill the crack with a waterproof material.

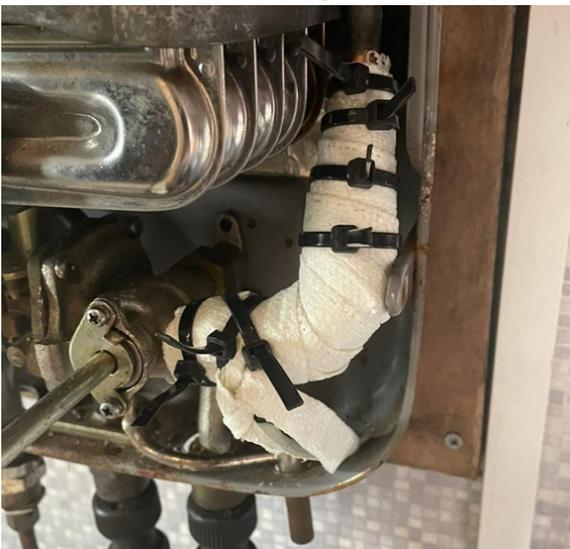
The space constraints meant SylWrap HD was cable tied in place whilst it cured, reinforcing the repair with a rock hard, protective outer shell

A **SylWrap HD Pipe Repair Bandage** was then applied around the entire pipe for reinforcement.

Wrapping in the normal manner was not possible due to the space constraints, so the bandage was cable tied to the pipe whilst it cured.

Once the repair was completed, the boiler was turned back on. No water was escaping the pipe, denoting a successful application.
