SYLWRAP Case Study

Libya 200mm 44 Bar Fuel Oil Pipeline Repair

A leaking underground fuel oil pipeline in Brega is sealed in a repair built to withstand pressure fluctuations up to 44 bar and temperatures of 70°C

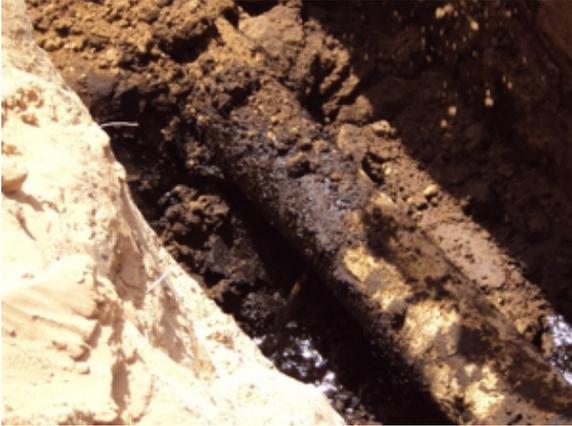
The pipeline was badly pitted and covered in oil

Excavation of the leaking oil line revealed it to be in terrible condition. It was badly pitted and covered in oil, which had escaped from a small crack caused by heavy corrosion.

The pipe was cleaned as best it could be. Oil and dirt were removed to enable a good connection between the surface and **Wrap & Seal Pipe Burst Tape**.

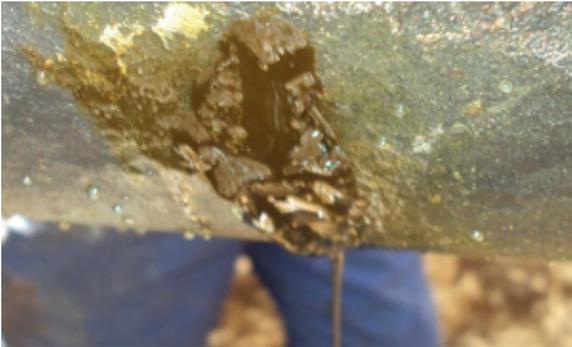
Oil was escaping from a small crack left by corrosion

Six 50mm x 4m Wrap & Seal were applied over the crack. The tapes amalgamated to form a solid rubber mass, strong enough to contain pipe content even in the event of 44 bar pressure being reached.

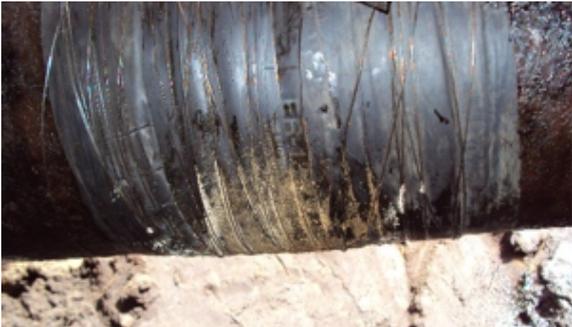
Multiple Wrap & Seal tapes fused into a solid rubber mass, containing the oil leak

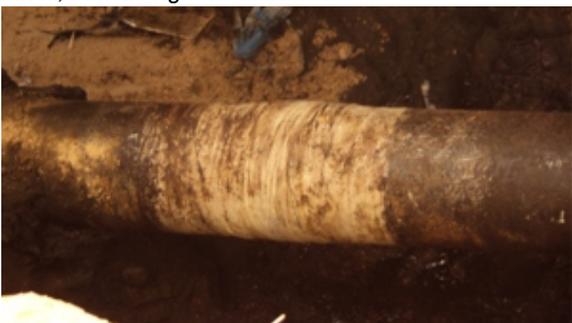
The repair was reinforced with SylWrap HD

The repair was then overwrapped with **SylWrap HD Pipe Repair Bandage**. Four bandages were used to create a thick, rock-hard, impact resistant sleeve reinforcing the pipe by increasing outer wall thickness.

With Wrap & Seal effective to 200°C and SylWrap HD offering a maximum service temperature of 200°C, the completed repair met both the temperature and pressure requirements.
