Sylmasta AB Case Study

19th Century Cast Iron Pit Wheel Refurbishment

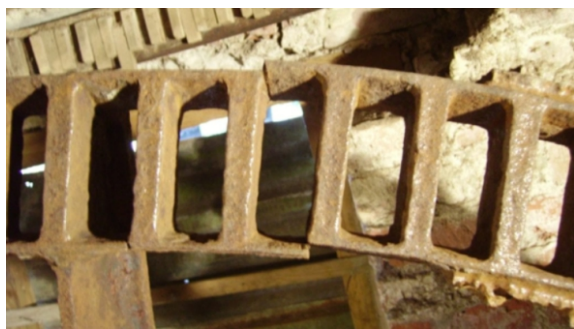
Damage caused to the original cast iron castings

Corrosion and time had weakened the castings of the wheel, which was also cracked in several places. Calculations indicated a future sudden impact would cause the casting to break apart again, possibly irreparably.

To reinforce the wheel, two steel hoops were to be fitted to the outer and inner castings. These could not be welded to the wheel as the cast iron might have exploded during the process due to its age.

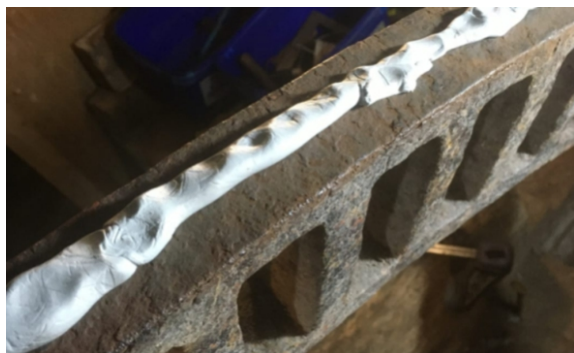
Sylmasta AB applied to the outer casting of the wheel

To overcome both issues, the Mill owner applied **Sylmasta AB Epoxy Putty** to the inside and outside castings prior to installing the steel hoops.

Sylmasta AB provided a water-resistant layer between the castings and the new hoops to prevent water ingress. It also helped bond the wheel to the hoops, which were held in place by clamps whilst the putty cured before being screwed in.

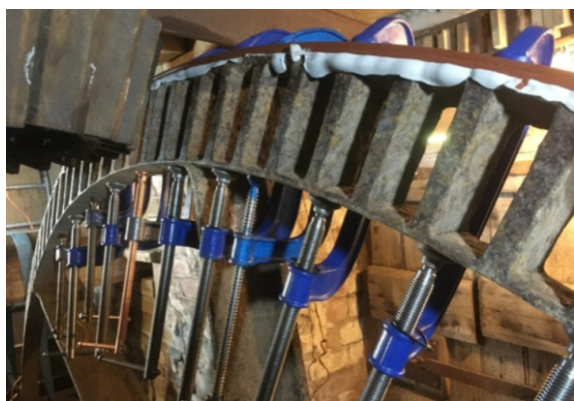
Clamps held the steel hoop in place whilst AB cured

The two hour work time of Sylmasta AB allowed more putty to be mixed in one go, enabling large sections of the steel hoop to be fitted without the threat of premature curing.

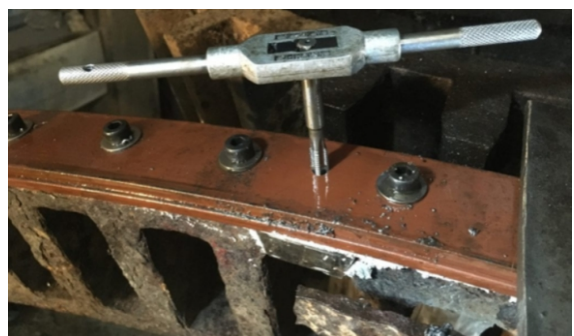
Hoop screwed into the wheel to complete repair
