E190Epoxy Adhesive
& Composite
Resin

Case Study

Pharmaceutical Plant Corroded Tank Repair

A pharmaceutical plant in Puerto Rico sought a repair method for a badly corroded industrial tank to keep it operational until a scheduled replacement

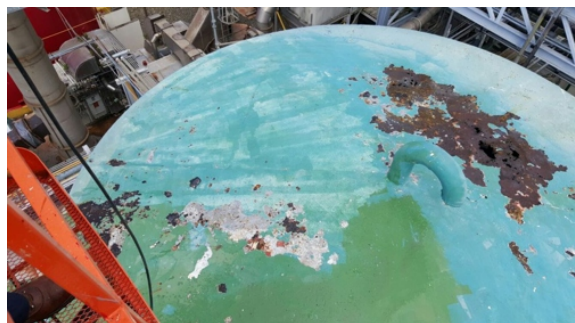
The tank roof was suffering from heavy corrosion

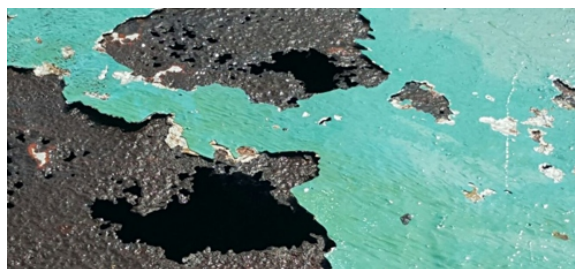
Whilst being cleaned in preparation for repair, the brittle metalwork crumbled away to leave large holes

Paint, rust and grime had to be removed from the roof before application of Ceramic Brushable. This process caused the brittle metalwork to crumble away, leaving multiple large holes which now required sealing.

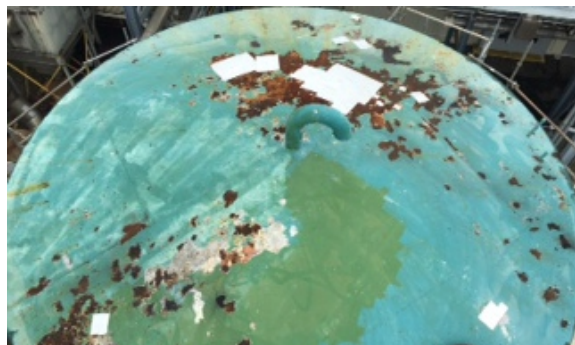
E190 Brushable Epoxy Resin was coated onto strips of Fibreglass Tape to patch repair the holes

Each hole was bridged using strips of **Fibreglass Tape** soaked in **E190 Brushable Epoxy Resin**. The tape was layered over the hole, where the E190 resin cured it rock-hard to create a composite patch repair.

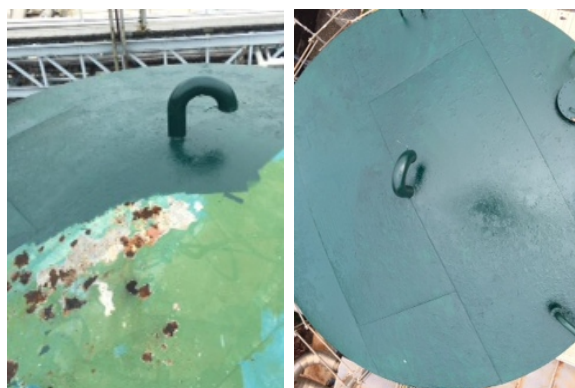
Three layers of Ceramic Brushable were painted onto the patched roof, creating a new outer surface with resistance to corrosion and abrasion

Three layers of Ceramic Brushable were then painted onto the roof of the tank with a re-coat time of four hours, completing the repair.
