SYLWRAP Case Study

Energy Company Repair District Heating Pipe

An energy company respond raidly to a leaking district heating pipe with a live leak repair which kept a building warm and prevented serious water damage

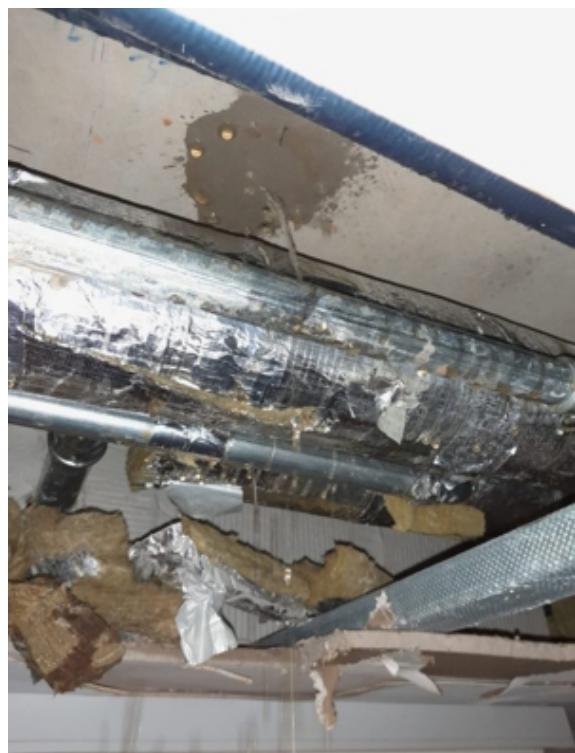
The steel pipe can be seen across the middle of the photo, spraying water out in all directions

A pinhole leak developed in a section of 50mm steel pipe suspended in the ceiling of the building. Water was jetting out in several directions, causing substantial damage to surrounding surfaces.

Flow could not be isolated as this would involve shutting down heating for the building. A live leak repair with materials lightweight for application from the top of a ladder was the only solution.

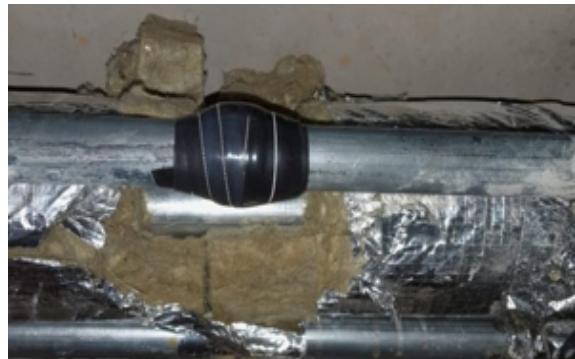
Wrap & Seal formed a solid rubber band over the leak

A contractor rushed to site with a Case, using **Wrap & Seal Pipe Burst Tape** to seal the leak. The tape is resistant to 260°C and despite the space constraints, could be stretched by the maximum 300%.

It amalgamated to form a solid rubber band, containing the leak. **SylWrap HD Pipe Repair Bandage** was then applied over the entire section, encapsulating the pipe with a rock hard outer shell.

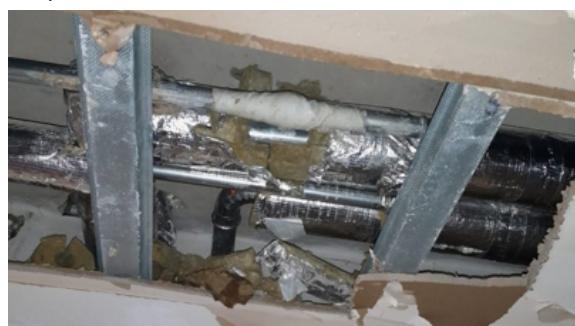
SylWrap HD reinforced the repair by creating a rock hard layer around the entire section of pipe
