# STEEL STICK

## Case Study

### Classic Car Frame Rust Holes Filler Repair

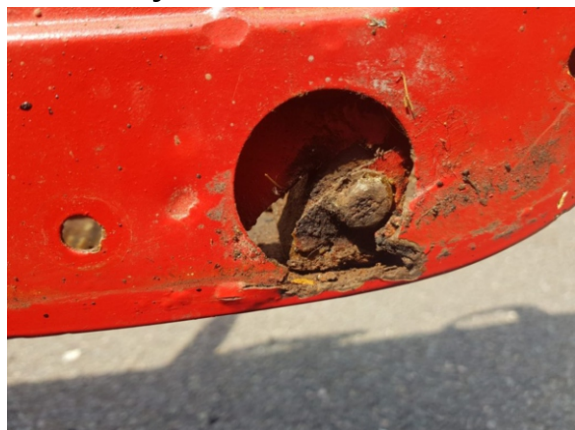
*Corrosion had eaten away at the metal frame of the car. It had caused rust holes to develop around a screw and the window mechanism to fail*

Corrosion had eaten away at an inside section of the classic car door where the window mechanism was anchored. This meant it was no longer possible to open and close the window properly.

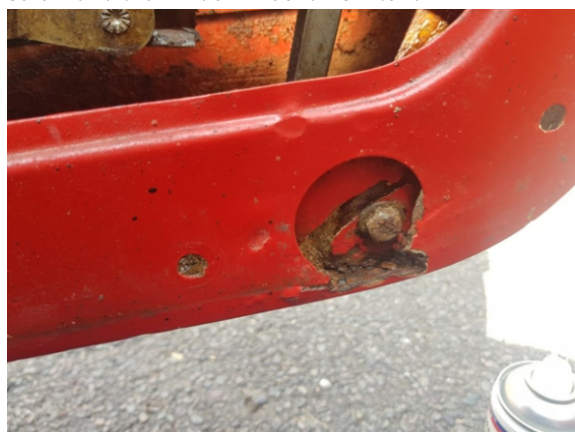
*Moisture Repellant Spray was used to drive moisture and grease from the hole. The metalwork was then further cleaned by removing dirt, grime and rust*

Moisture Repellant Spray was applied to drive grease and moisture from the hole. The area was then cleaned of dirt, rust and grime. **Superfast Steel Epoxy Putty** was used to fill the hole.

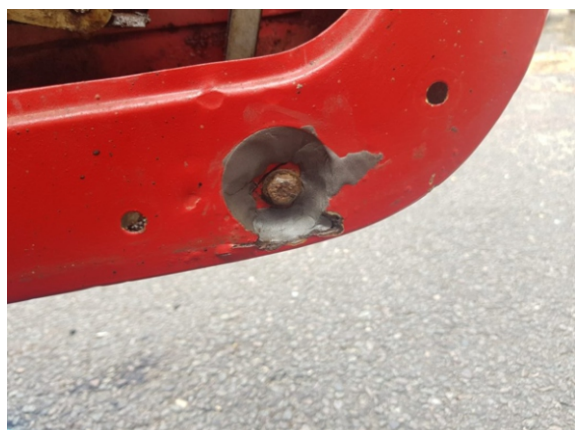
*Superfast Steel was pushed into the hole and shaped around the screw, filling the damage. Once cured, it was filed and painted red to match the car frame*

The required amount of putty to fill the damage was cut from the stick and kneaded by hand. Whilst soft, it was pushed into the hole, shaped and moulded around the screw.

Within 10 minutes, Superfast Steel hardened into a material sharing the look and feel of steel. Full properties were reached in one hour. The putty was then filed and painted red to match the car frame.
