# SYLWRAP Case Study

## Fire Station Reinforce Corroded Steel Pipe

A six metre section of 150mm steel pipe with two elbow bends at a fire station pumping house is reinforced before corrosion could breach the line

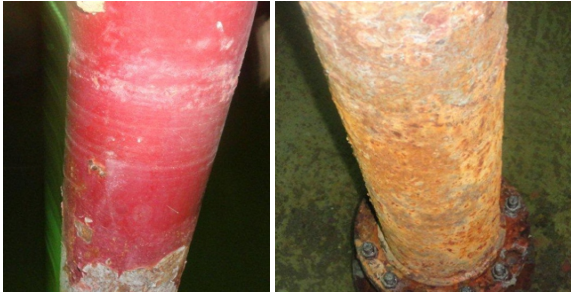
*The steel pipe was badly corroded, especially in its lower sections beneath the surface of the reservoir*

Heavy corrosion had weakened the pipe over many years, especially the section submerged in water beneath the surface of the reservoir. It was now only a matter of time before the line was breached.

Starting from the upper level and working down, **SylWrap HD Pipe Repair Bandage** was wrapped along the entire six metre length of pipework.

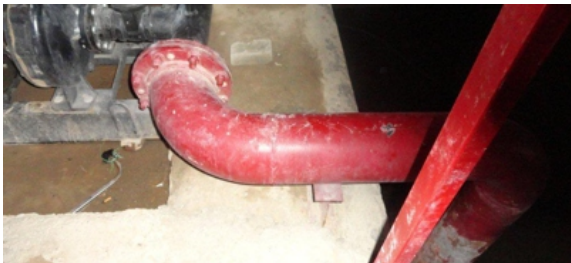
*There were two elbow bends in the line, providing a difficult geometry for wrapping around*

SylWrap easily moulded around the complex shape of the line and could be applied effectively underwater. This enabled it to reinforce both the elbow bends and the section of pipe passing through the reservoir.

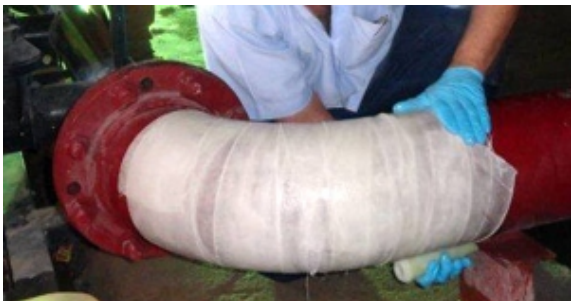
*SylWrap HD applied to one of the elbow bends*

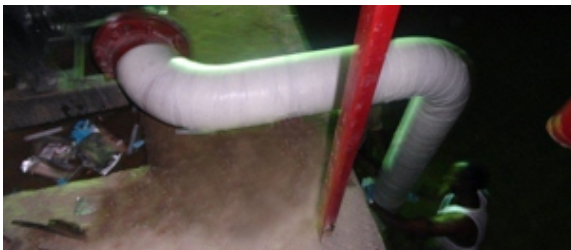
*Completed reinforcement of the upper section of pipe*

Once cured, SylWrap formed a rock hard shell around the entire pipe. It protected the line from external corrosion and would contain pipe content in the event of an internal breach.

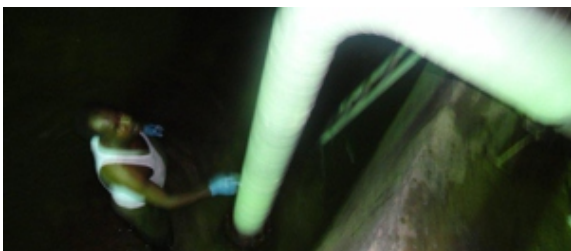
*SylWrap HD successfully applied to the lower section*
