SYLWRAP Case Study

Quarry Wash Plant Leaking Elbow Bend Repair

A leak close to a 90 degree bend in a 150mm steel pipe at a UK quarry forced the site to seek an alternative repair method to their normal use of a clamp

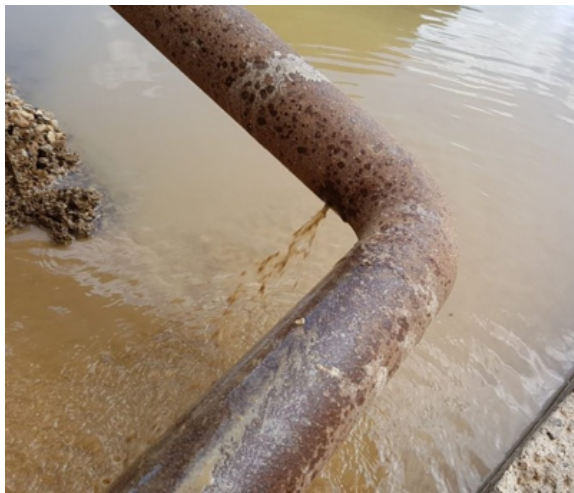
The pipe was located in the quarry wash plant, passing over a lake. A pinhole leak developed around 50mm from the elbow bend, allowing foul water to escape into the lake below.

The 150mm steel pipe was leaking from a pinhole close to a 90 degree elbow bend, meaning that a pipe repair clamp would not be effective

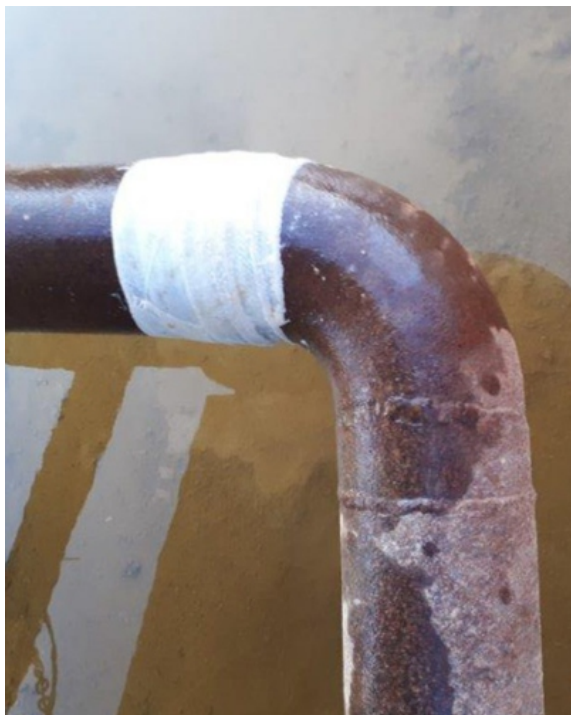
Superfast Steel are SylWrap HD Pipe Repair Bandage provided a permanent repair despite the challenges posed by the elbow bend

The pipe was cleaned prior to the repair. **Superfast Steel Epoxy Putty Stick** was kneaded by hand and pushed into the pinhole whilst soft. Within 10 minutes, it hardened to seal the leak in the pipe.

A **SylWrap HD Pipe Repair Bandage** was then applied around the leaking section. Once activated with water, the resin set rock hard in minutes to create an impact resistant sleeve around the pipe, reinforcing and protecting the repair.
