SYLWRAP Case Study

Live Leak Pipe Repairs on Libya Water Network

Above and below ground water pipes servicing a town in Libya undergo live leak repair to seal cracks through which high levels of water were escaping

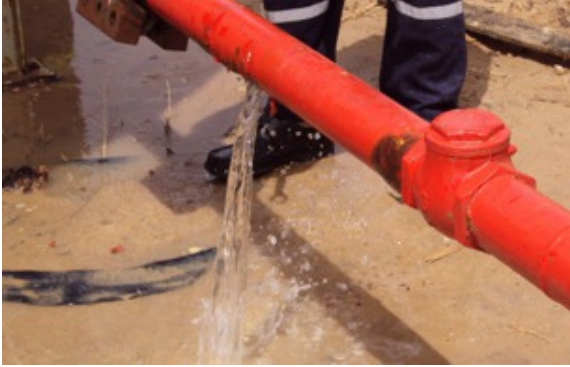
Significant levels of water were escaping the above-ground section of pipe at 5 bar pressure from a longitudinal split

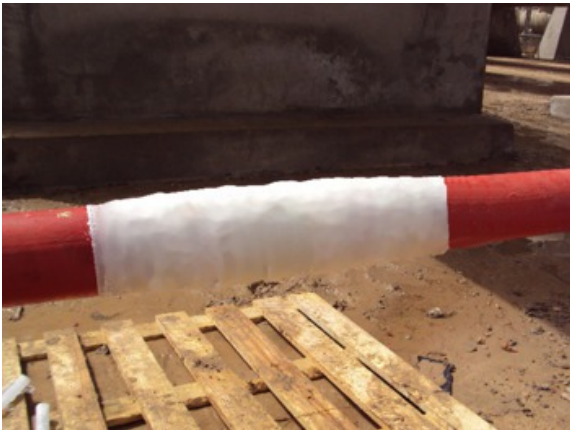
The above-ground section was successfully sealed using Wrap & Seal and then further protected with SylWrap HD Pipe Repair Bandage

For the above-ground pipe, **Wrap & Seal Pipe Burst Tape** was wrapped along the length of the split.

Multiple Tapes were applied over each other until no water was leaking, indicating the repair had reached 5 bar pressure resistance. A **SylWrap HD Pipe Repair Bandage** was then applied to protect the Tape.

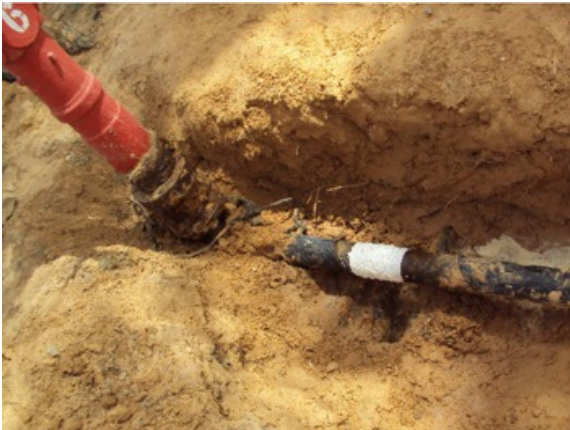
A trench was dug with enough clearance to reach the below-ground section of pipe. It was then repaired using Wrap & Seal and SylWrap HD Bandage

A trench was dug to reach the below-ground section with enough clearance to wrap both Wrap & Seal and SylWrap around the pipe. The small crack in the pipe was easily arrested.
