# Epoxy Putty Case Study

## Protecting Wooden Entrance Gates Against Rot

After a storm destroyed wooden entrance gates to a Scottish estate, robust replacements were built with AB Original providing protection against rot

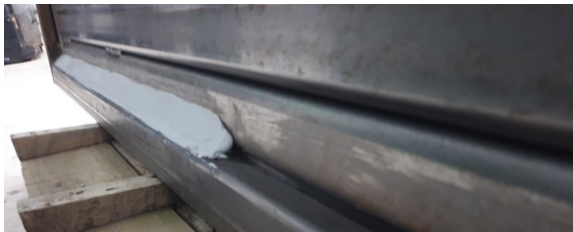
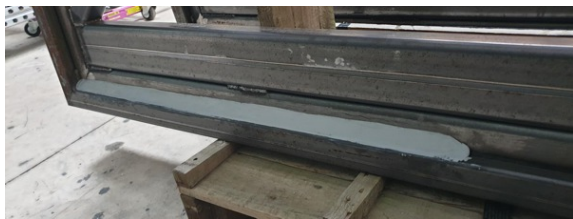
A strong steel frame was built for the replacement gates, onto which wooden slats would be fitted

The destruction of the previous gates led the estate to fabricate replacements. A strong steel frame capable of withstanding extreme weather was to have wooden slats attached via stainless steel self-tapping screws.

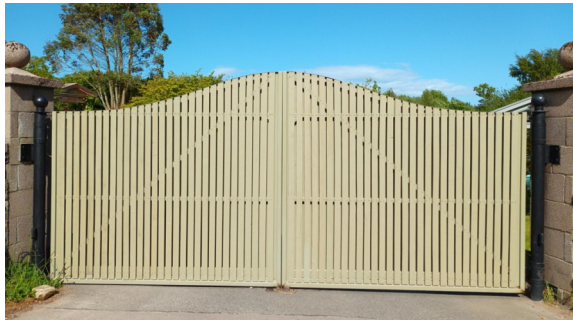
AB Original was formed into a bevelled edge to create a run-off preventing water pooling at the base of the frame and rotting the slats

One issue with the design was an area at the base of the frame where rainwater could pool with no means of escape other than evaporation - potentially causing future rotting to the bottom of the slats.

To prevent rainwater pooling, the estate came up with the ingenious idea of using epoxy putty to create a bevelled edge at the base of the frame.

This edge would divert water onto the ground, ensuring no contact with the wooden slats. The bottom of the slats were also bevelled, creating a 5mm gap through which water could pass.

**Sylmasta AB Original Epoxy Putty** was chosen for its waterproof qualities and two-hour work time, offering long enough for the putty to be formed into the shape of a bevelled edge before it cured off.

The putty easily adhered to the steel frame, and its ultra-smooth finish provided a perfect run off for rainwater. The steel frame and putty were then painted beige, making the entire gate appear wooden.
