Liquid Metal

Case Study

Creating Anti Slip Surfaces for Helicopter Legs

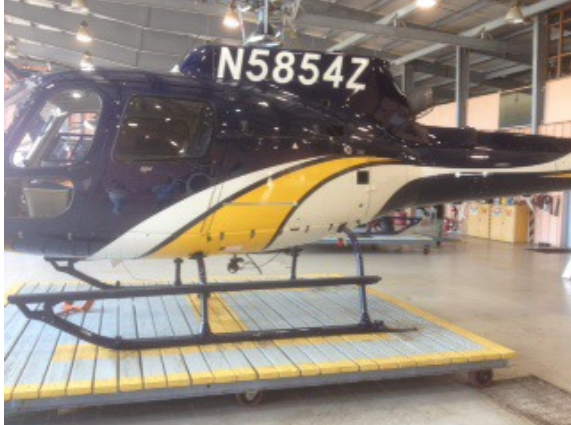
A helicopter belonging to the Puerto Rico Power Authority. Some maintenance jobs involved workers standing on the legs of the helicopter, which had anti slip tape applied as a means of protection

Some maintenance tasks carried out by the fleet of helicopters required workers to stand on the metal legs. These legs had anti slip tape applied.

The harsh environments the helicopters operated in meant new tape had to be applied once a month. This was time consuming and costly.

There were also concerns about the safety of the tape. The frequency with which it became worn and damaged led the Power Authority to seek a longer term, more trustworthy alternative.

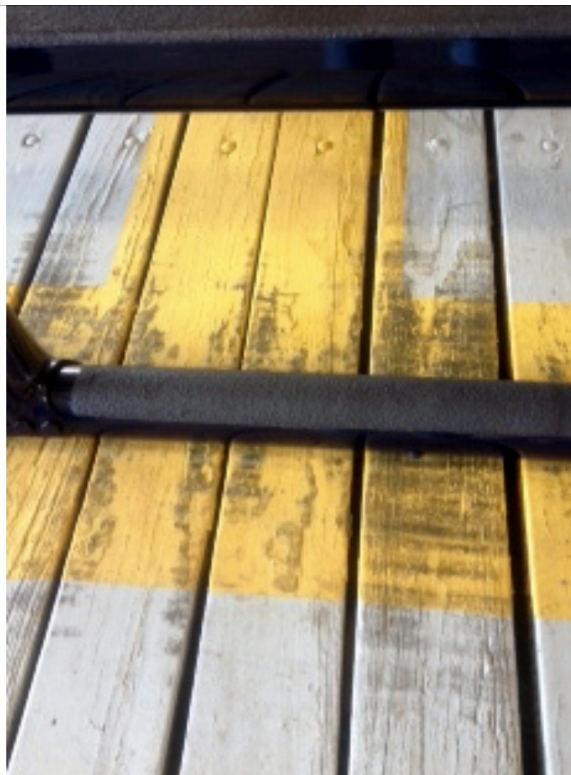
Liquid Metal was coated onto the legs and silicon carbide deposited over the top. Once the epoxy had cured, the grit was permanently bonded to the skids to create a long term anti slip solution

Sylmasta suggested coating each helicopter skid with **Liquid Metal Epoxy Coating** and then applying silicon carbide grit to the wet surface, creating a robust anti slip surface.

Liquid Metal offers high strength adhesion to all materials. The coating was applied across the top of each skid, forming a new metallic layer.

Silicon carbide was then deposited over the epoxy, completely covering the skid. Once Liquid Metal cured, the grit was permanently bonded to the helicopter leg.
