SYLWRAP Case Study

Heavily Corroded Steel Pipe Reinforcement

An industrial site in Saudi Arabia rebuild and reinforce 2 metres of steel pipe before heavy external surface corrosion could eat through and breach the line

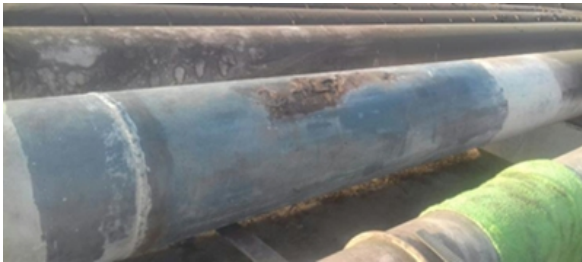
The 2 metre long section of steel pipe to be reinforced, with the 600mm patch of heavy corrosion in the middle

The pipe was suffering from a 600mm patch of heavy corrosion to its external surface. It was only a matter of time until this corrosion ate through the remaining brittle steel to breach the line.

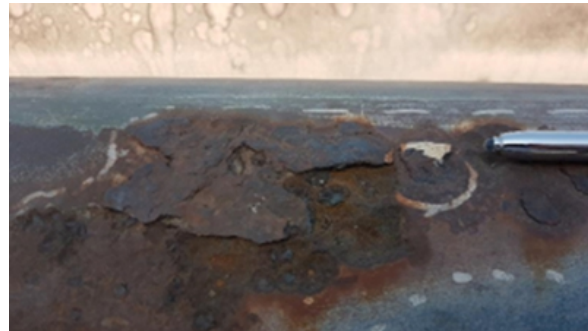
Closer inspection of the corroded area showed how much external surface damage the pipe had suffered

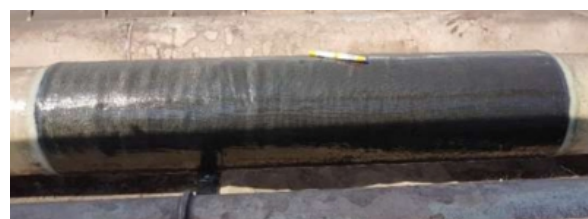
SylWrap CR was applied to a 2 metre section of the line, centred around the corroded area rebuilt using Sylmasta AB. The corrosion inhibitors in SylWrap CR provided greater protection in such an aggressive environment, compared to SylWrap HD

SylWrap CR was then wrapped over a 2 metre section of the pipe, including the putty. SylWrap CR contains corrosion inhibitors for further protection of pipework in harsh and aggressive environments.

Within minutes of being activated with water and applied, SylWrap CR had cured to form a rock-hard sleeve around the pipe, further reinforcing the line and protecting it from future corrosion.

Reinforcing the line took around half a day. There was no disruption to production on site as the line remained in full operation throughout.
