Epoxy Putty Case Study

Fence Posts Suffering Concrete Cancer Repair

A homeowner installing a new trellis fence uses AB Original to repair posts damaged by concrete cancer, avoiding the huge task of replacing every spur

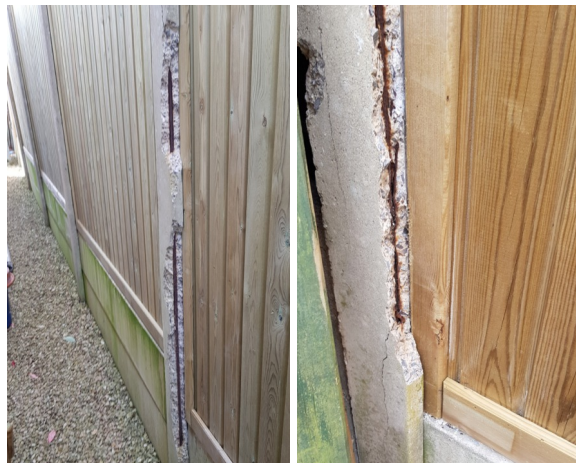
Concrete cancer had caused serious damage to the fence posts, worsened when they were disturbed during the installation of the new trellis

Having been in place for over 30 years, the fence posts were badly damaged by concrete cancer.

When they were disturbed during the replacement of the trellis, the posts shed huge chunks of concrete. This worsened the problem.

Over 10kg of **Sylmasta AB Original Epoxy Putty** was used to fill the damage. The two-hour work time allowed large quantities to be mixed and applied without premature curing.

The putty was pushed into the damage whilst soft. It easily adhered to the concrete. Once set, it permanently replaced chunks of concrete which had been destroyed.

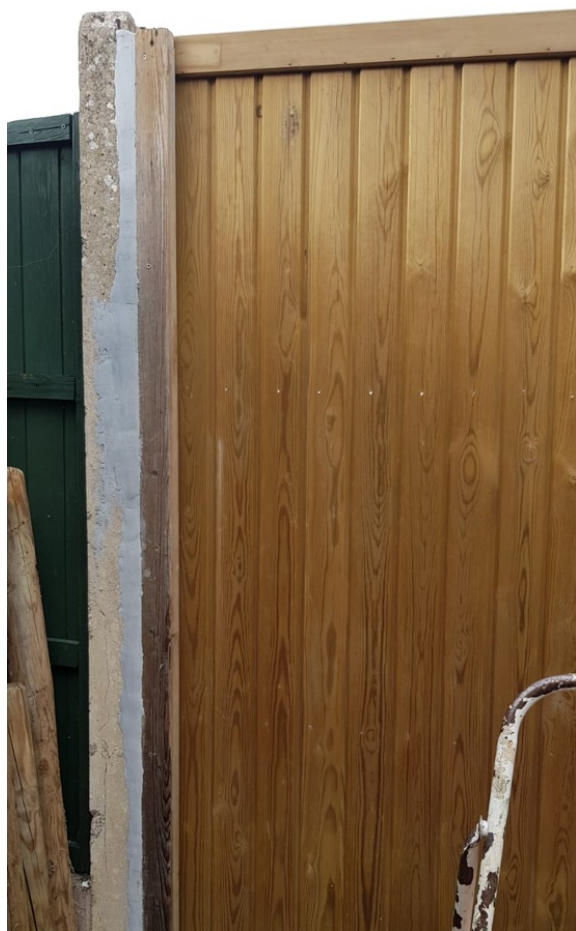
AB Original filled in all the damage in every fence post, whilst also offering protection to the inner steel rods against future corrosion

AB Original is available in three colours. Grey was chosen for its resemblance to concrete. It has high corrosion resistance and is waterproof.

The cured material therefore better protected the steel inside the posts from corroding, helping to prevent future concrete cancer.
