Sylmasta AB Case Study

Fence Posts Suffering Concrete Cancer Filler Repair

A homeowner installing a new trellis fence uses epoxy putty to repair posts damaged by concrete cancer, avoiding the huge task of replacing every spur

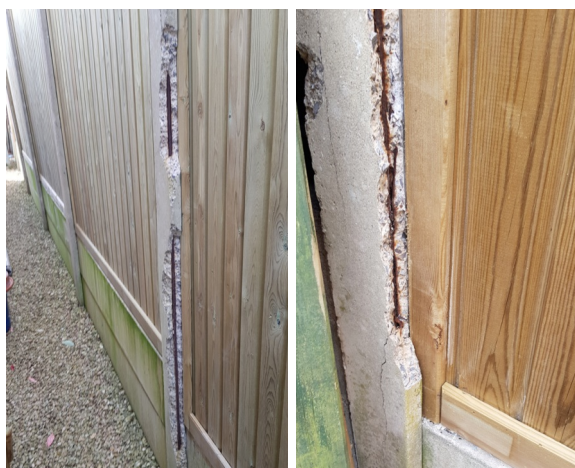
Concrete cancer had caused serious damage to the fence posts, worsened when the posts were disturbed during the installation of the new trellis

Having been in place for over 30 years, the fence posts were badly damaged by concrete cancer.

When they were disturbed during the replacement of the trellis, the posts shed huge chunks of concrete. This worsened the problem.

Over 10kg of **Sylmasta AB Original Epoxy Putty** was used to fill the damage. The two-hour work time allowed large quantities to be mixed and applied without premature curing.

The putty was pushed into the damage whilst soft. It easily adhered to the concrete. Once set, it permanently replaced chunks of concrete which had been destroyed.

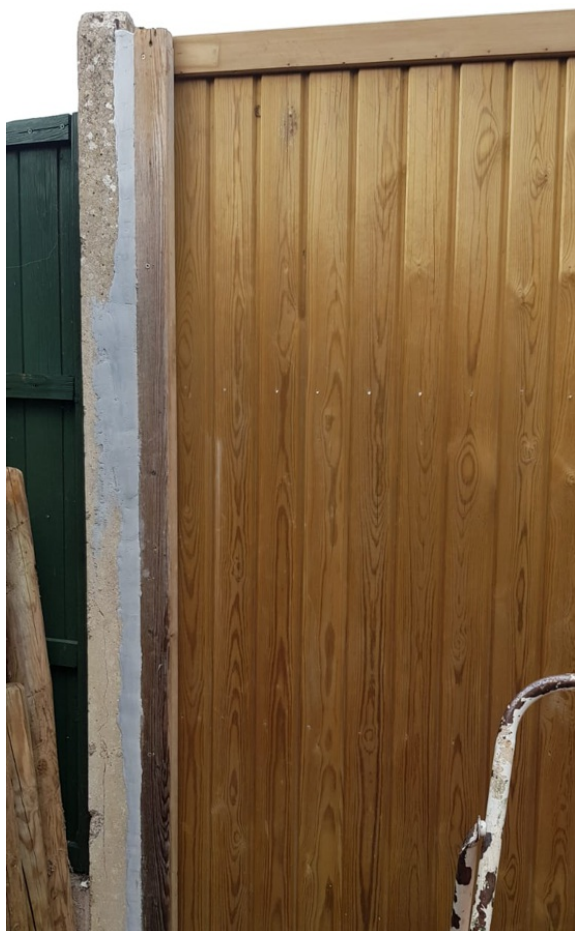
Sylmasta AB filled in all the damage in every fence post whilst also offering protection against corrosion to the inner steel rods

AB Original is available in three colours. Grey was chosen for its resemblance to concrete. It has high corrosion resistance and is waterproof.

The cured material therefore better protected the steel inside the posts from corroding, helping to prevent future concrete cancer.
