# SYLWRAP Case Study

## Reinforcing Welded Corners in Acid Tank

New corners welded in place during the repair of a chromic acid tank undergo reinforcement for additional sealing security in case of leaks in the welding

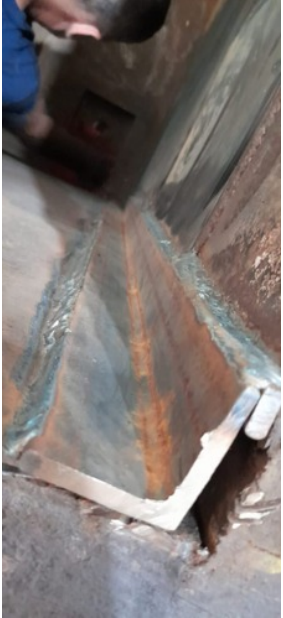
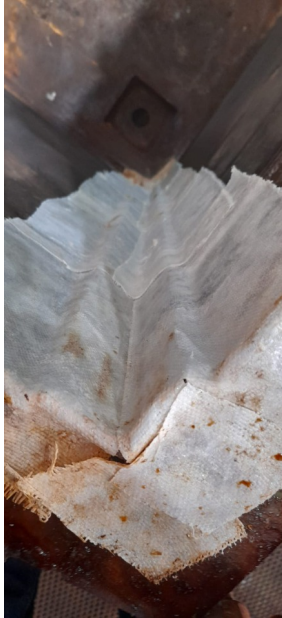
*New metal corners were welded to reinforce all four corners of the chromic acid tank. These corners were then encompassed with SylWrap HD Bandage*

After years in service, the tank was suffering from corrosion which was particularly heavy in all four corners. These corners were repaired by installing welded reinforcements to the inside of the tank.

The factory unwound and cut a **SylWrap HD Pipe Repair Bandage** into patches, making sure not to contaminate the Bandage with dirt or grime.

These patches were activated with water and pressed and smoothed tightly up the entire length of welded reinforcement in all four corners.

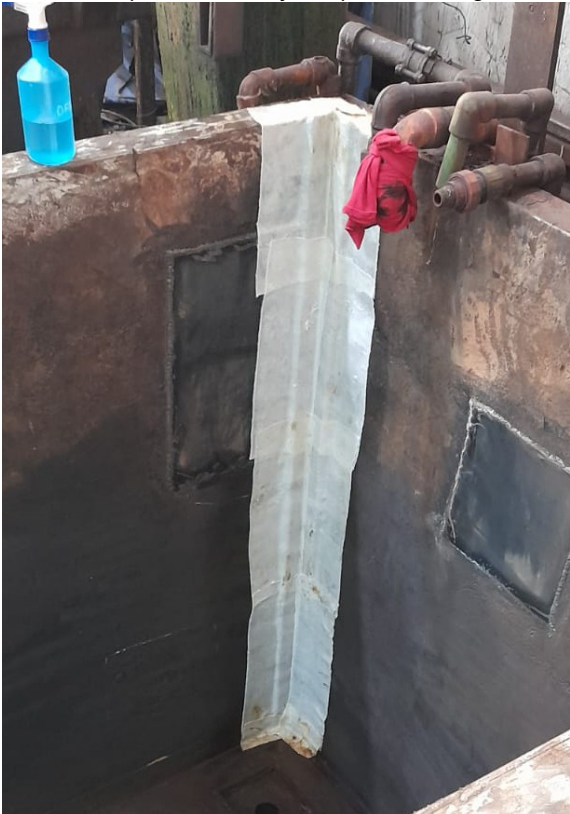
*Patches of SylWrap HD pressed and smoothed over each corner created a watertight seal between the weld and the existing iron frame of the tank*

SylWrap HD cured within 10 minutes to form a rock-hard shield, creating a watertight seal between each weld and the frame of the tank and covering any gaps or holes otherwise left exposed.
