SYLWRAP Case Study

Cement Coated Steel Pipe Live Leak Repair

A cement coated steel pipe on a water network in Mexico undergoes live leak repair after removal of the outer coating revealed a 80mm long split in the line

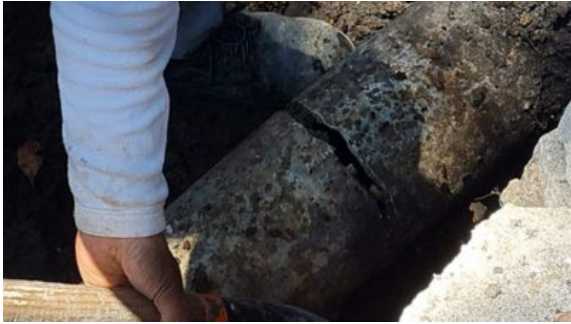
A 15mm crack was discovered in the cement coating of the pipe, although no leakage was detected

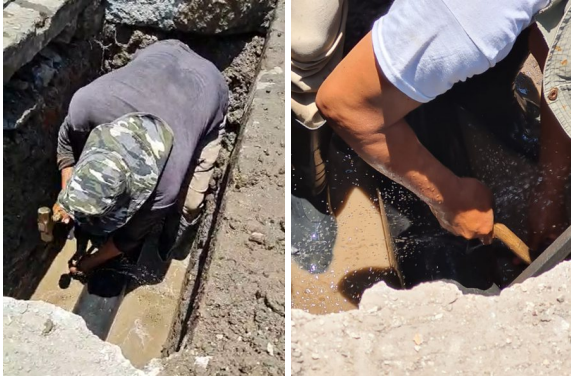
As the cement coating was removed, water began spraying from a 80mm long split in the steel pipe

There was no sign of leakage through the crack. To inspect the condition of the steel inside, the cement was removed. As the coating was cut away, water began spraying from a 80mm long split in the pipe.

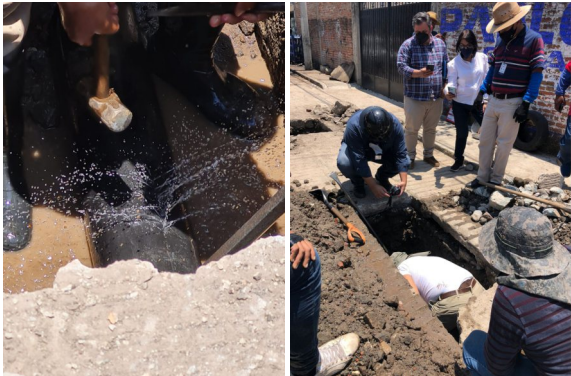
Once the coating had been fully removed, the steel pipe was sealed using a SylWrap Contractor Case

Wrap & Seal Pipe Burst Tape was used to seal the pipe. Multiple Tapes were wrapped up the length of the split until the leak had been arrested via the building of a repair resistant to 3bar.

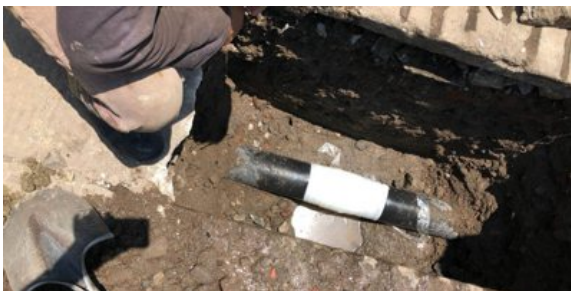
After the leak was sealed with Wrap & Seal, SylWrap HD Bandage replaced the protective concrete coating

A **SylWrap HD Pipe Repair Bandage** was then wrapped and smoothed over the pipe. It set rock hard in minutes, providing an impact resistant sleeve to replace the removed cement coating.
