Wrap & Seal PIPE BURST TAPE Case Study

Pump House Leaking Welded Saddle Joint Repair

A 150mm steel pipe connected to a pumping house leaking from both ends of a welded saddle joint is sealed in a repair built up and over a 20mm step

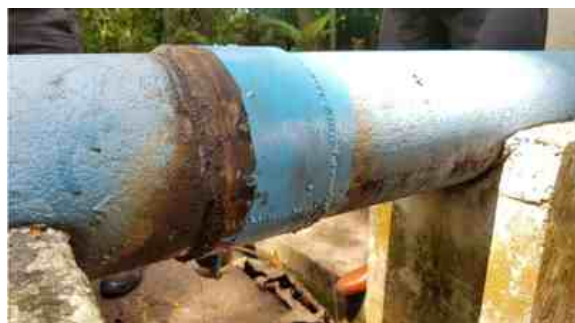
Water was seeping from both ends of the saddle joint, one of which was suffering from heavy corrosion

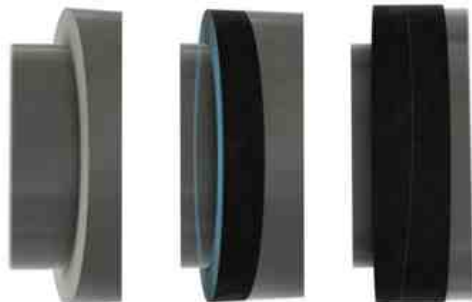
Wrap & Seal application began next to the saddle, was built up until level with the step and then continued across onto the joint

Wrap & Seal was first applied directly next to the step. Each rotation added another layer until the step was bridged, after which wrapping continued 50mm across the saddle.

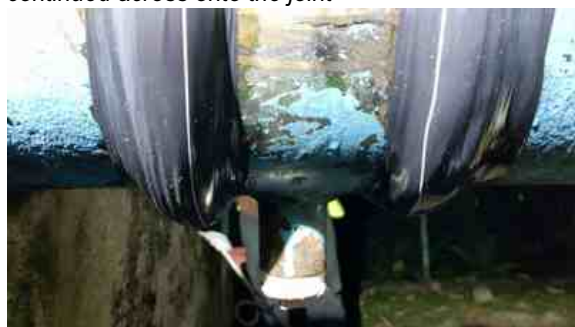
Once the joint ends had been encapsulated, Wrap & Seal was applied directly over the leak to create a ridge increasing the pressure resistance of the repair

Wrapping then returned to the edge of the joint, where a ridge was created over the leak area to increase the pressure resistance of the repair.

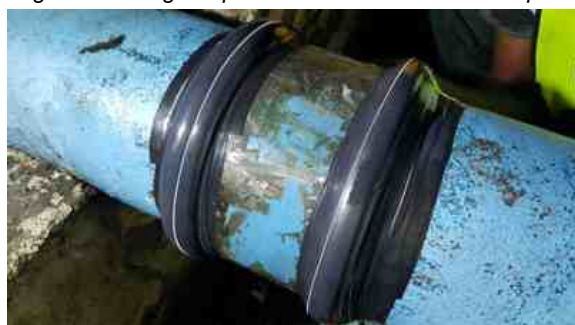
Wrap & Seal was applied to both ends of the saddle joint, successfully sealing the pipe

Three Wrap & Seals were used to seal one end of the saddle, after which the process was repeated at the other end of the joint.

When the pipe surface was found to be dry, the application was deemed a success.
