SYLWRAP Case Study

Sugar Mill Alcohol Line Live Leak Pipe Repair

Having a SylWrap Contractor Case on site enabled a sugar mill in Costa Rica to make an instant repair when a pinhole leak developed in an alcohol line

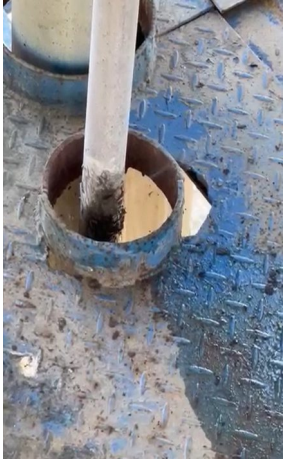
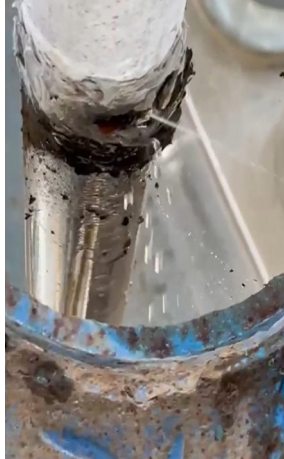
Alcohol juice was spraying through a pinhole leak at a point where the line passed through a circular hole in the upper floor of a platform

A pinhole leak developed in a weakened section where the line passed through a circular hole in an upper floor of the platform. Alcohol juice was left spraying out at around two bar pressure.

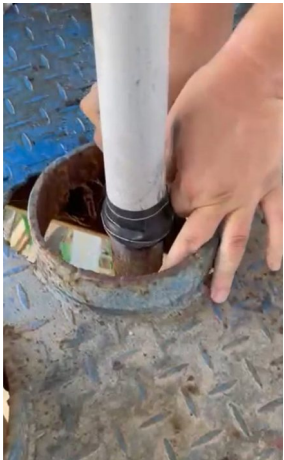
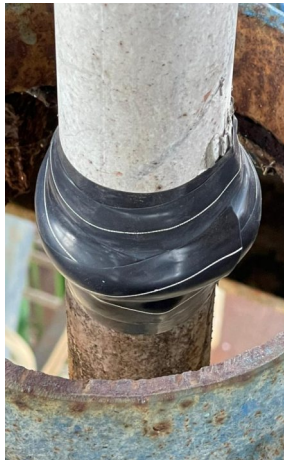
Wrap & Seal Pipe Burst Tape sealed the live leak despite the space constraints around the pipe

The line could not be isolated, so **Wrap & Seal Pipe Burst Tape** was used to seal the leak. Despite the space constraints around the pipe, the Tape was stretched and amalgamated successfully.

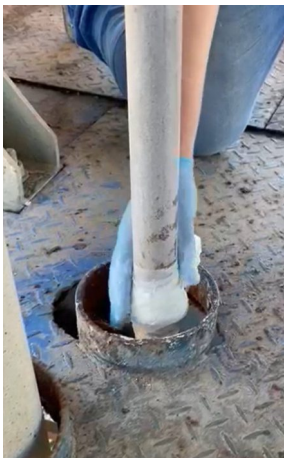
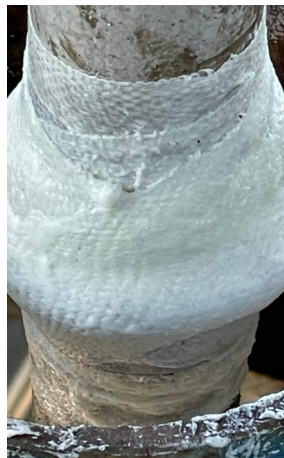
The repair was reinforced and protected with SylWrap HD Pipe Repair Bandage

Once the engineer making the repair was satisfied the leak was sealed, a **SylWrap HD Pipe Repair Bandage** was applied for reinforcement.
