# Epoxy Putty Case Study

## Home Renovation Rotted Oak Beam Repair

Large voids where a wooden beam had rotted are filled in to create a flat surface, enabling the outside of a home to be rendered during renovation

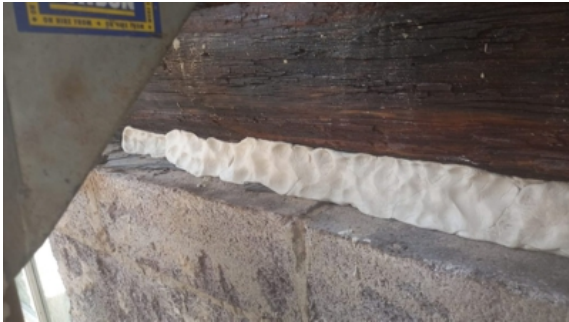
*AB Original was pushed into all gaps in the wooden beam left by rotting, permanently filling the damage*

Unfortunately, the beam was badly rotted in places with large voids left. These needed to be filled and a flat surface created so rendering could take place.

Each 200g stick was kneaded by hand. Whilst soft, the putty was pushed into the voids to fill all the gaps. It easily adhered to the damaged wood.

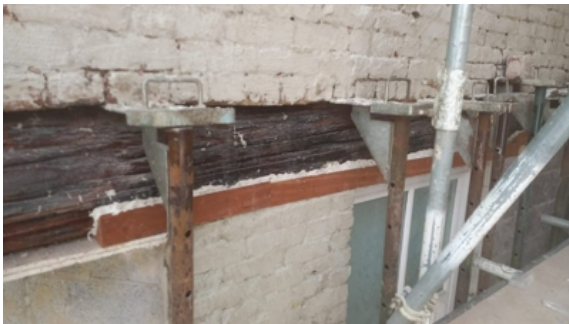
*Hardwood inserts were bonded to the AB Original in areas where voids were particularly deep, helping to reduce the amount of putty needed for the application*

For larger voids, hardwood inserts were added to reduce the amount of AB Original needed. The putty permanently bonded the inserts in place.

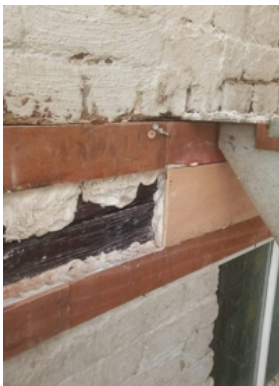
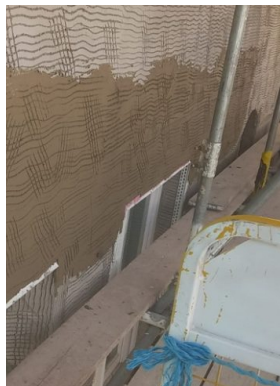
*The repair created a flat, smooth surface which could be rendered onto directly*

Where AB Original remained exposed, a little water was used to create an ultra-smooth finish for the putty.

The application of AB Original was completed over several days. The cured material itself could be rendered onto directly, helping to make adding the cement coating a straightforward task.
