SYLWRAP Case Study

Hospital Repair Cracked Cast Iron Downpipe

A 1.05-metre long crack in an internal cast iron downpipe leaking rainwater into a hospital ward is sealed in 30 minutes with no disruption to patients and staff

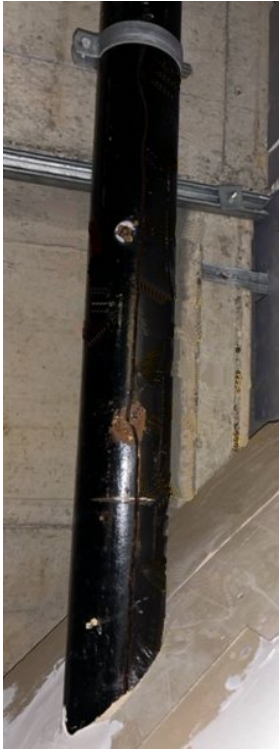
Water escaping through the 1.05-metre long crack in the downpipe had saturated surrounding plasterboard and was now leaking into a nearby hospital ward

The hospital had an ageing 150mm diameter cast iron pipe system taking rainwater away through the building. A leak into a ward alerted staff to a problem in a wall cavity containing a section of downpipe.

A drainage engineer accessed the cavity and pipe, discovering a 1.05-metre crack. Budget restraints and the possibility of new facilities being built meant replacing the damaged pipework was not viable.

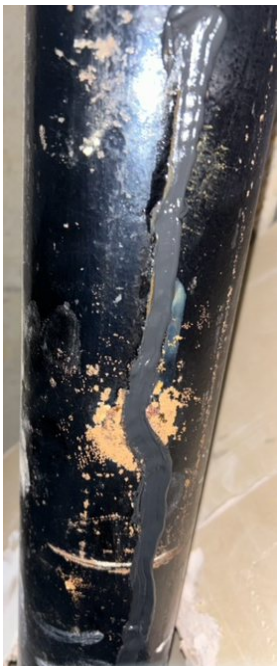
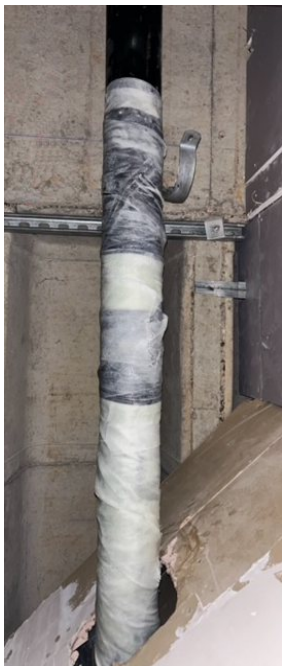
The crack was sealed by extruding CrackSeal directly into it. The entire length of pipe was then reinforced with SylWrap HD for a permanent repair

CrackSeal Sealant was extruded directly into the crack until it was totally filled. It hardened almost instantly to seal the crack, after which it was left for 10 minutes to form a skin.

Two **SylWrap HD Pipe Repair Bandages** were then wrapped along the length of the crack. SylWrap set rock-hard within minutes, forming an impact resistant sleeve protecting both the CrackSeal repair and pipe.
