SYLWRAP Case Study

600mm Concrete Water Main Pipe Break Repair

A city authority in Canada reduce a significant 2 bar leak down to a slow drip by repairing a break in an underground 600mm concrete water main pipe

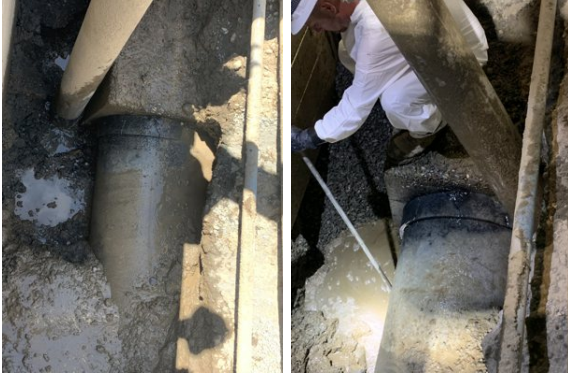
The break was somewhere beneath the joint in the pipe at the point it passed into the concrete wall

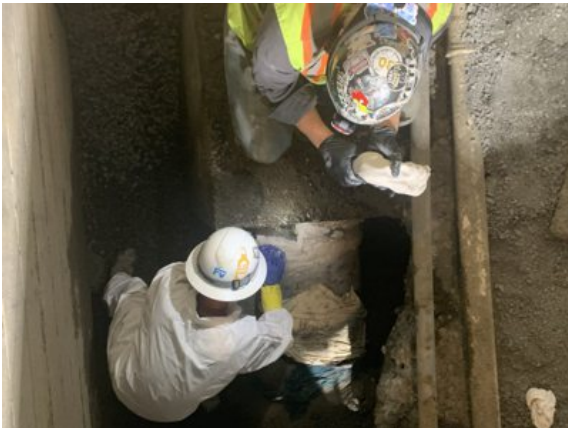
Two maintenance workers mixed AB Original Sticks by hand inside the hole, packing the putty around the leaking joint in the pipe

Pressure was reduced as much as possible from 2 bar and just under 8kg of **Sylmasta AB Original Epoxy Putty** used to seal around the entire joint.

The putty was supplied in 200g sticks, mixed by hand and then packed around the joint. AB Original has high wet surface adhesion, enabling it to bond to the pipe even with water pouring out during the repair.

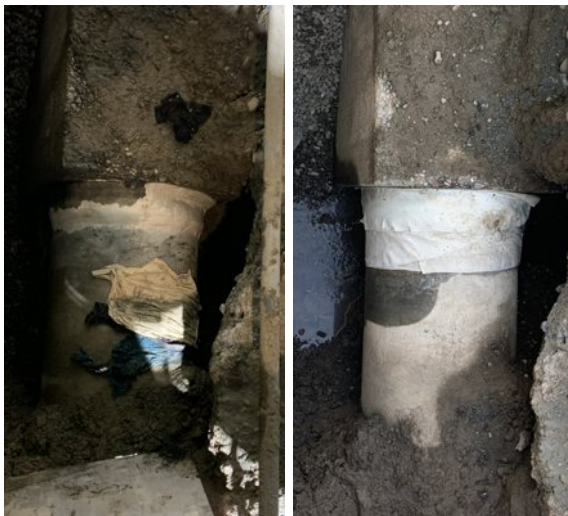
Once water loss had been reduced to an acceptable level by encompassing the leak area, the repair was reinforced with SylWrap HD Bandage

Once water loss had been reduced to a slow drip, the putty was overwrapped with 2 x SYL866HD **SylWrap Pipe Repair Bandage**. SylWrap formed a rock-hard outer shell, increasing the effectiveness of the repair.
