SYLWRAP Case Study

Water Treatment Plant 6 Bar Live Leak Repair

A water company in Malaysia make their first repair with a SylWrap Contractor Case, sealing a 6 bar live leak on a 300mm steel pipe at a treatment plant

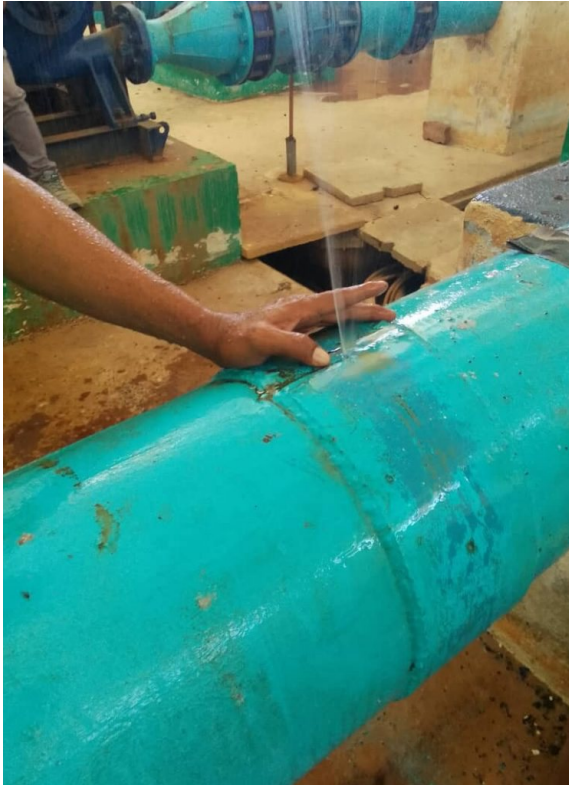
Water had been escaping the 300mm steel pipe for two weeks through a 4mm hole at 6 bar pressure

The pipe had been leaking for two weeks through a 4mm hole. It could not be shutdown because of its importance to operations at the plant, leaving a steady jet of water escaping and saturating the floor.

Such a leak would normally be sealed by the water company using a clamp. The hole though was located in a welded saddle joint sitting 15mm above the original pipe, making a clamp ineffective.

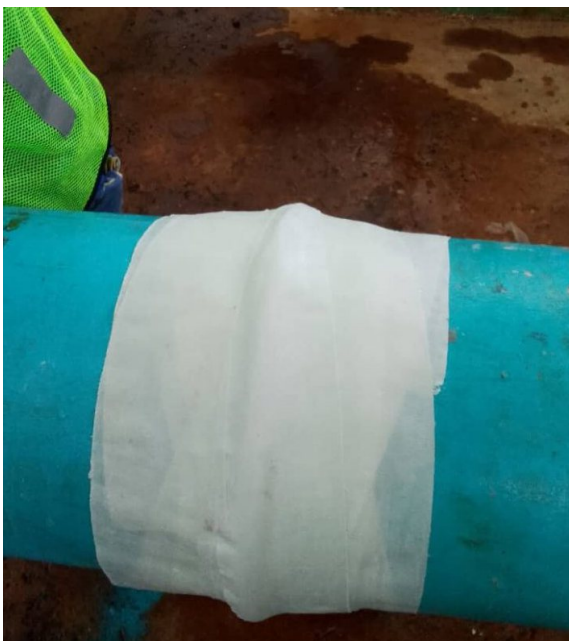
Three 50mm x 11m Wrap & Seals built a repair with enough resistance to withstand 6 bar pressure, followed by reinforcement with SylWrap HD

Three 50mm x 11m Wrap & Seal were applied over the pinhole until water was no longer seeping through. This indicated the tapes had amalgamated together, building enough pressure resistance to hold 6 bar.

The repair was reinforced with a SYL866HD **SylWrap Pipe HD Repair Bandage** which formed a rock-hard, impact resistant shell protecting the Wrap & Seal.
