# SYLWRAP Case Study

## Oil Refinery Repair Leaking Water Cooling System

An oil refinery carry out a significant pipe repair programme after microbially induced corrosion caused welded joints in the water cooling system to fail

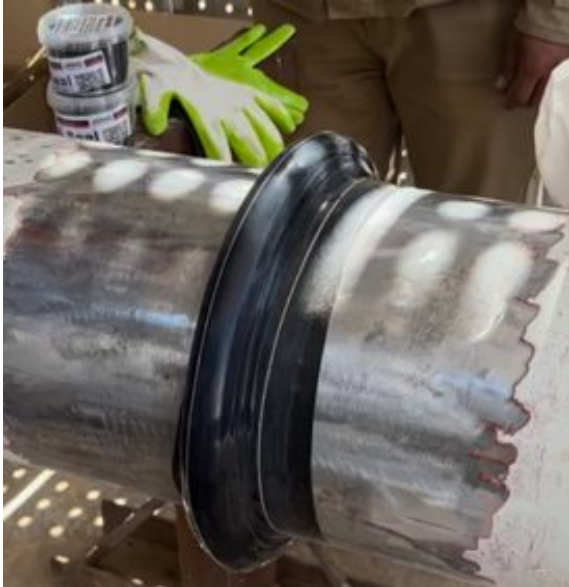
The stainless steel water cooling system was meant to have a lifespan of 50 years, yet numerous welded joints had started leaking after less than half that time.

Microbially induced corrosion (MIC) was found to be the cause, attacking the pipe interior where welding had damaged the stainless steel's passivation layer.

Over 1,700 **Wrap & Seal Pipe Burst Tape** and 500 **SylWrap HD Pipe Repair Bandages** were sent to the refinery. Sylmasta also flew to the Middle East to train installers and supervisors on using the products.

Whenever a leak now develops, **Wrap & Seal** and **SylPad Pressure Resistance Multiplier** are on-site and ready to make online repairs capable of holding the 10 bar pressure the system operates at.

After sealing, each welded joint is overwrapped with **SylWrap Bandage** for a permanent, reinforced repair.

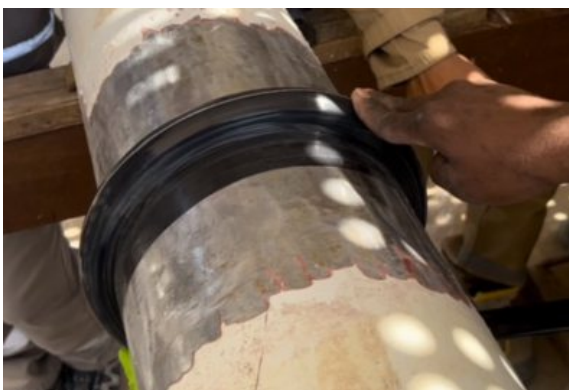
*Multiple Wrap & Seal applied to leaking welding joints built repairs capable of holding 10 bar pressure*

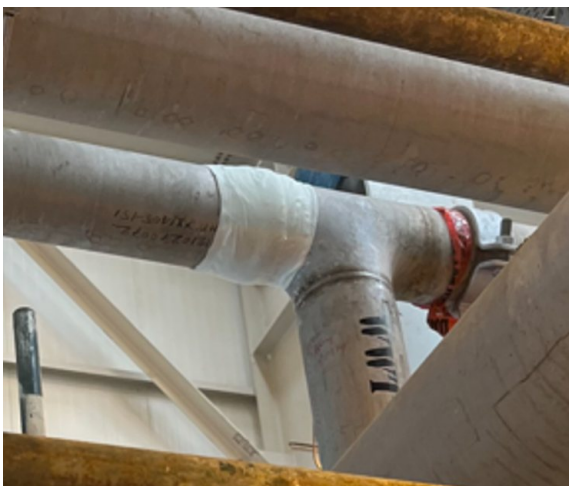
*Repairs were reinforced with SylWrap HD, including to difficult-to-access sections of overhead pipe*

Since Sylmasta's visit, the refinery have repaired numerous leaks - including to overhead and difficult-to-access sections of pipework in constrained spaces.
