SYLWRAP Case Study

Bilge Pipe Leak Repair On Board Superyacht

A leaking bilge pipe on board a superyacht is sealed after corrosion at a welded joint created a hole in an area of the line where it was impossible to fit a clamp

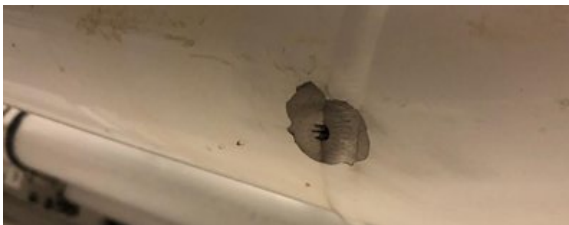
Corrosion had attacked a weak spot at a welded joint in the steel pipe, creating a hole close to a 90-degree elbow and the hull of the superyacht.

The leak was also surrounded by other pipes and equipment, making repair using a clamp impossible.

Corrosion had made a hole in a welded joint near an elbow bend. The leak was also surrounded by other pipes and equipment, leaving no room to fit a clamp

A **SylWrap Pipe Repair Contractor Case** was sent to the superyacht, from which **Wrap & Seal Pipe Burst Tape** was used to seal the leak.

The tape was stretched by three times its length. It self-amalgamated as it was wrapped to form a solid rubber band containing the 2 bar pressure of the line.

SylWrap HD Pipe Repair Bandage then reinforced the repair. It was applied over the tape, curing to form a rock-hard protective sleeve around the pipe.

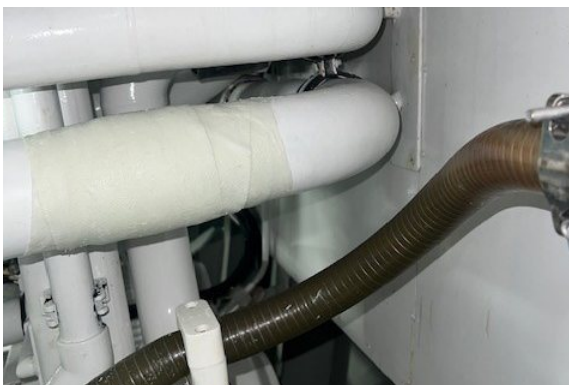
Wrap & Seal sealed the leak with pressure resistance to 2 bar, followed by overwrapping with SylWrap HD for reinforcement and protection
