# Liquid Metal Epoxy Repair Coating

## Power Plant Heat Exchanger Corrosion Protection

A power plant in Thailand uses Liquid Metal to protect a heat exchanger plenum chamber, tubes and a condenser faceplate against corrosion

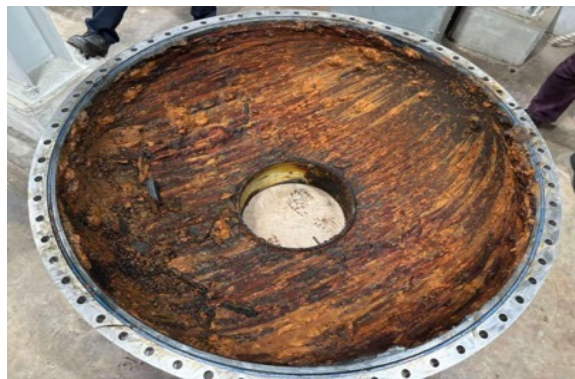
Extreme temperatures, high pressure and unpurified water passing through the plenum chamber created ideal conditions inside for corrosion and cavitation.

A standard epoxy coating had been used for many years to protect the chamber. But the rate of corrosion meant a new coating had to be applied annually.

Based on these requirements, Sylmasta recommended **Liquid Metal Epoxy Coating**. Three coatings 1mm thick were painted onto the internal metalwork, tubes and condenser faceplate.

The repair created a 3mm thick metallic outer layer over the original parts, offering ultimate protection against corrosion and cavitation.

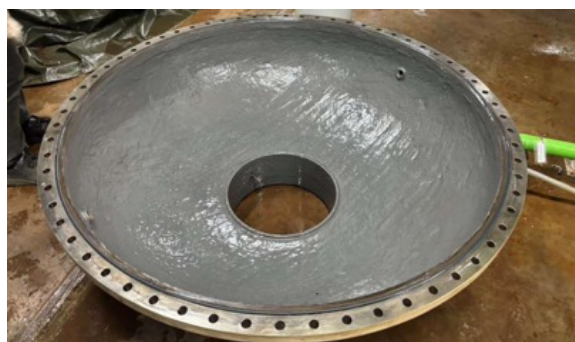
*Liquid Metal repaired the heavily corroded metalwork inside the heat exchanger plenum chamber*

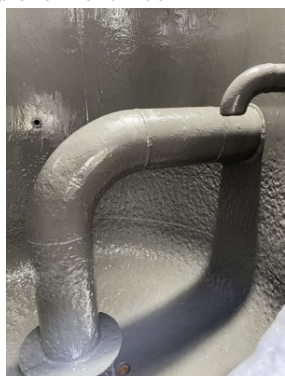
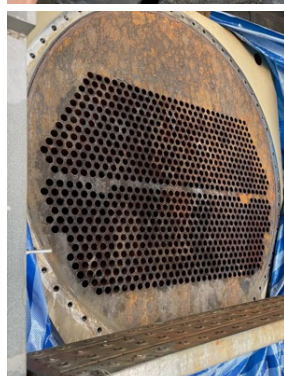
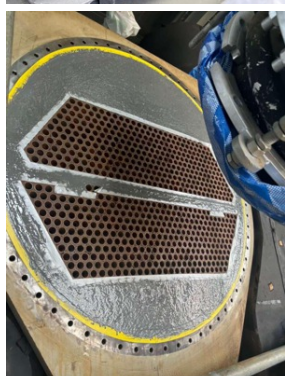
*Worn tubes inside the chamber and the condenser faceplate were also refurbished with Liquid Metal*
