CERAMIC BRUSHABLE

Case Study Warehouse Metal Storage Pallets Repair

Metal pallets damaged from years of having heavy, abrasive landscaping materials stacked on them are repaired using Ceramic Brushable Blue

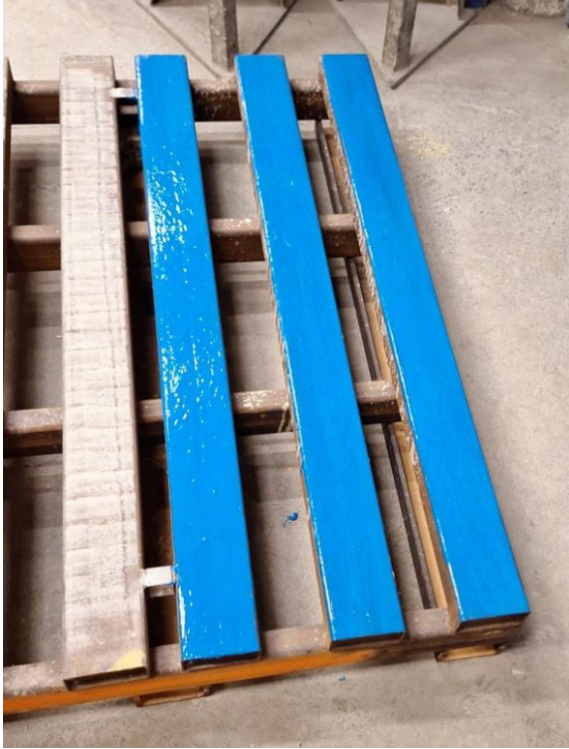
Metal pallets used to store landscaping materials had been left with impact and abrasion damage

The weight, abrasive nature and the impact of moving these materials on and off the pallets meant the metal slats had become damaged over time.

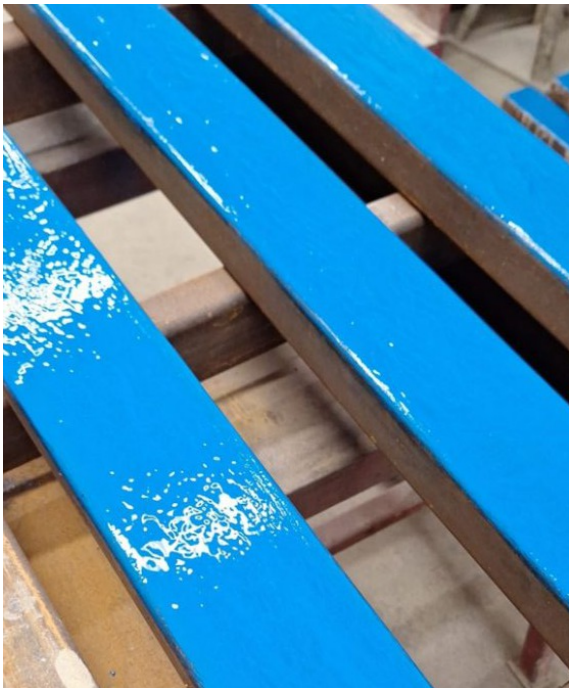
Ceramic Brushable Blue was used to coat the metal slats which came into contact with the abrasive, heavy materials to protect them from future damage

Ceramic Brushable is reinforced with silicon-carbide for ultimate hardness and a smooth finish. Two coatings were applied over all metal pallet slats.

Once cured, Ceramic Brushable formed a 2mm thick outer layer protecting the metalwork against impact damage and abrasion.
