Epoxy Putty Case Study

Clan MacGregor Dalmally Burial Stones Restoration

Sylmasta manufacture a version of AB Original colour-matched to RAL 7037 to help the Dalmally Burial Stones go on display for the first time in 400 years

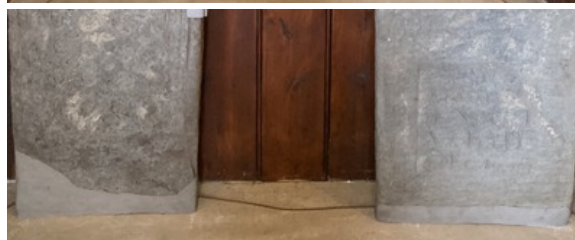
Missing chunks from the bottom of the Dalmally Stones were replaced with a specially manufactured version of AB Original colour-matched to RAL 7037

One major challenge during the restoration came from huge chunks missing from the base of the stones, leaving them unable to stand properly on display.

Graciella Ainsworth Sculpture Conservation asked Sylmasta to formulate a special version of **AB Original Epoxy Putty** colour-matched to RAL 7307 for an unobtrusive repair of the stones.

AB Original was then used to replace the missing chunks from each stone and create a flat, bottom edge. Once set, it formed a ceramic-like material similar to the original stone in texture and colour.

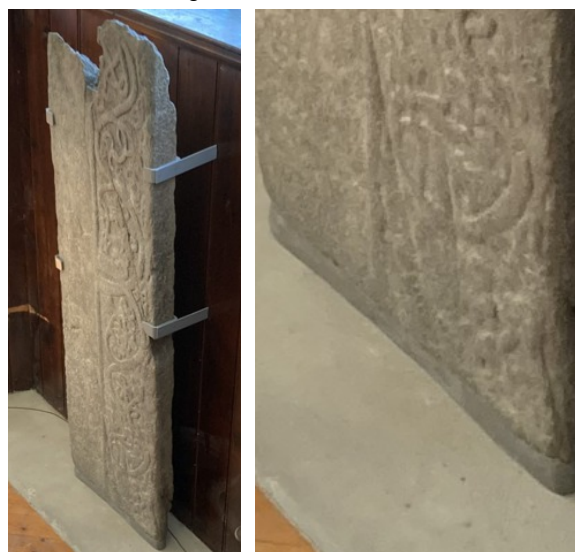
AB Original RAL 7037 blended in with the original stonework and helped the stones stand on display inside the church for the first time in 400 years

The rebuilt bases helped the Dalmally Stones be fixed inside the church for the first time in 400 years. Members of the *Clan Gregor Society* flew to Scotland from across the world for the dedication ceremony.
